THE EDICULA IMMERSIVE EVENT

The case of the Varnakova Monastery in Fokis: The rehabilitation of the Katholikon

The Architectural Approach

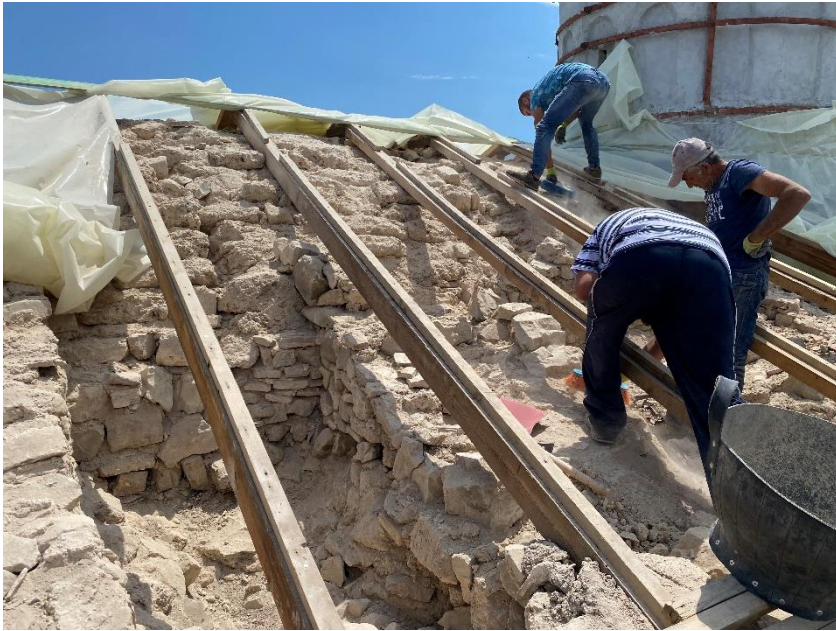
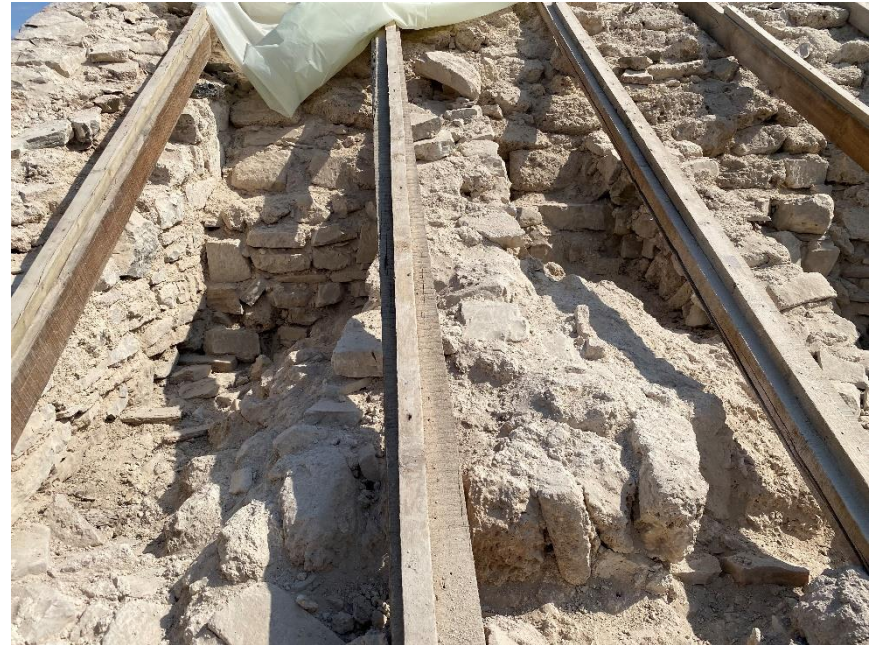
Photos: Zafeiris Vasilis

During the repair works, the **roof** was opened and its **construction was revealed**. It is a complex system of the newer phase, in which the slope of the roof is formed by stone gables, the gaps between which are bridged with wooden logs. The gaps are filled with stones and mortar. Stone slabs, wooden logs, slats and tiles were placed on top.

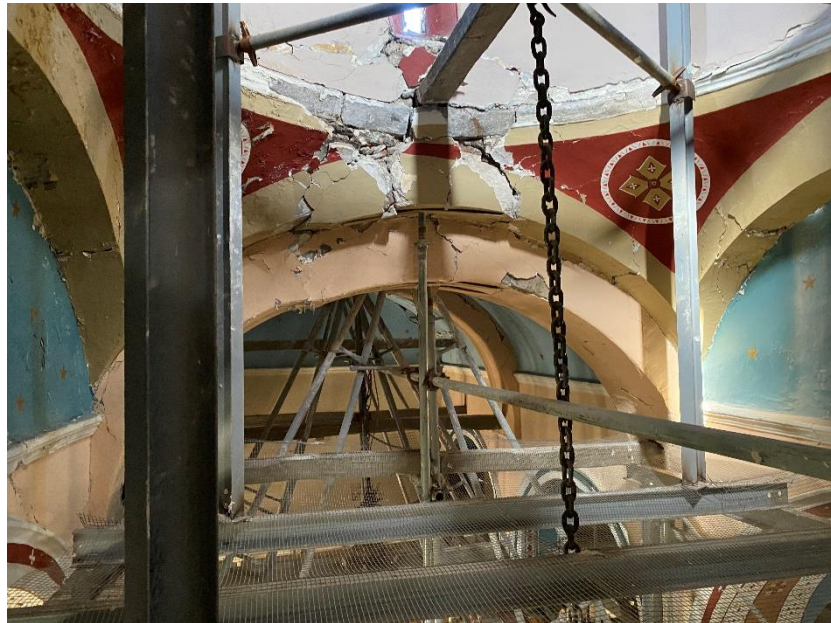
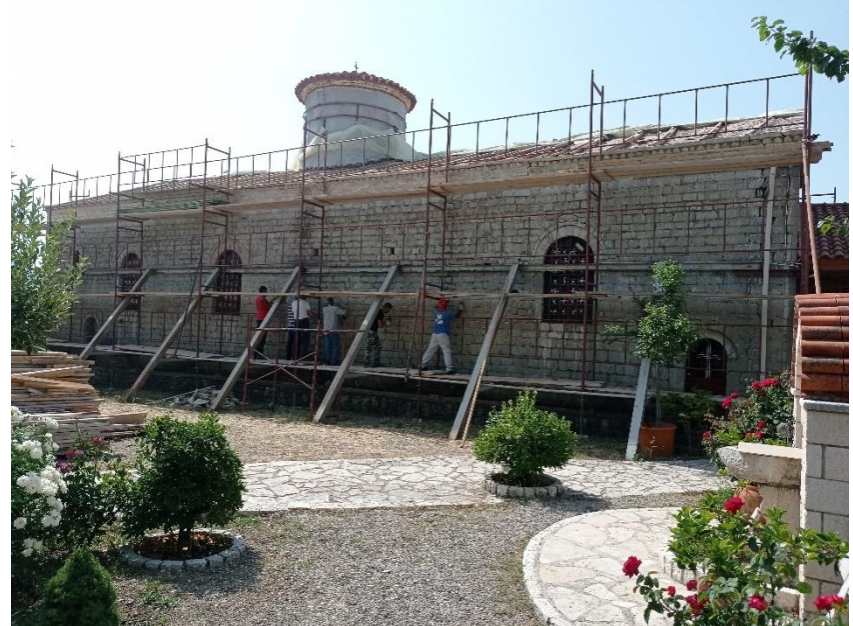
The bearing structure of the Katholikon is a **seismically vulnerable body**, whose seismic behavior is typical to that of the basilicas, as it has been historically recorded.

The church presents significant deformation, which led to the buttress of the **perimetrical masonry** and the support of its roof.

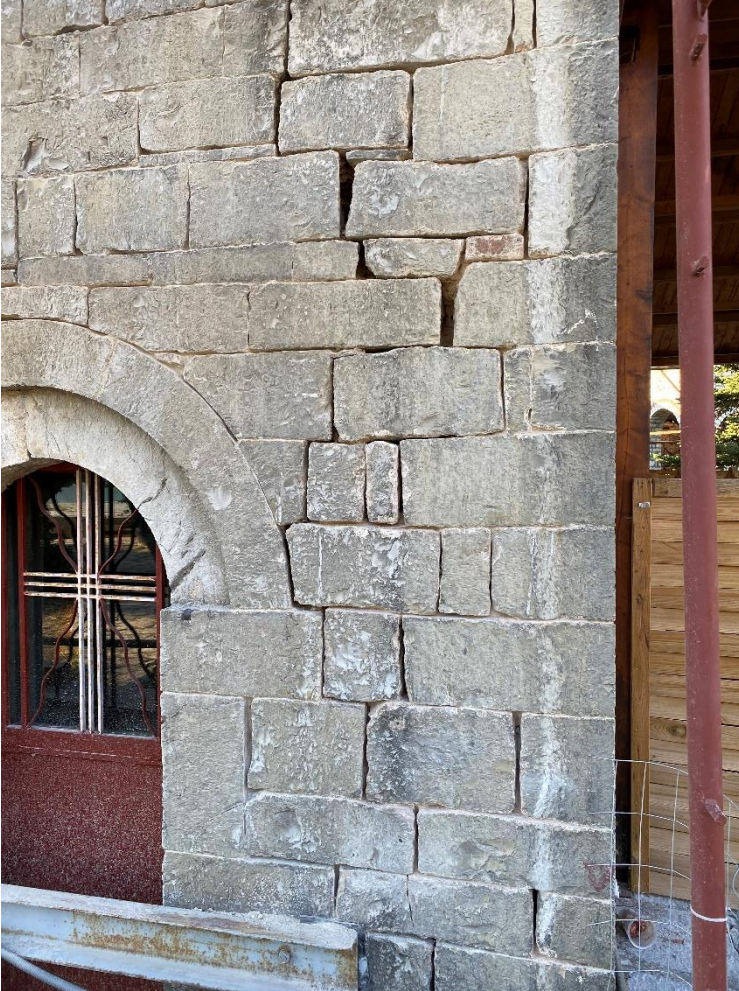
Perimetrical Masonry

The temple is made externally of isodomic stonework, which shows cracks of significant width in the areas of openings and corners, as well as loss of bonding mortar.

Internally, there is a significant horizontal crack at a low level, in both the northern and southern masonry. This crack indicates a possible subsidence of the foundation soil of the temple. After exploratory sections, it was found that the foundation of the temple is very superficial.

1. Jointing

A careful inspection of the joints will be carried out, in order to identify the areas with washed or loose joint mortar, which need new joint mortar, as well as the areas where the original joint mortar can be fixed (impregnation with lime water and special solutions, plastering) by specialist personnel, who have the necessary knowledge and previous maintenance experience.

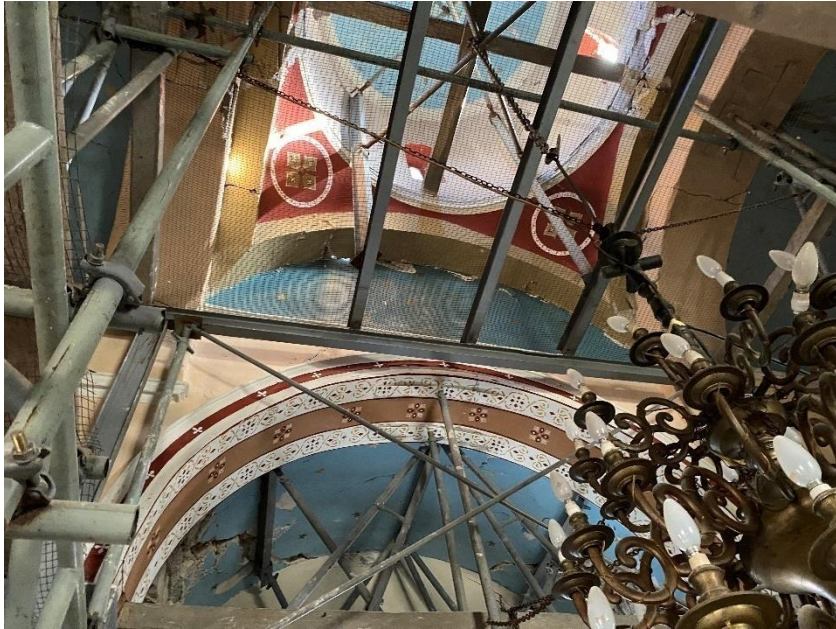
Arches and Vaulting

The arches in the transverse direction of the temple show significant pathology, in contrast to the arches in the longitudinal direction, which are in good condition. The arches are connected with wooden tension rods in both directions.

The vaulting system of the temple is in bad condition. In its entirety, the roof of the temple is supported by beams and columns created by grids with tubular beams, which are in contact with the masonry and carry the loads of the superstructure to the floor through wooden inserts. A protective grid has been placed at the height of the column capitals to hold the detached materials from the superstructure. The dome is internally supported by beams perpendicular to each other, placed horizontally, while externally it is covered with cement mortar and has a clamp at three levels.

The out-of-level movement of the North and South wall has caused the cracking of the entire vault in all three naves.

3. Installation of tension-compression rod system in the arches

- To strengthen the vaulting, a general application of grouting is carried out and then tension-compression system is placed at the origin of the arches in both directions inside the temple.
- Alongside, vaulting reinforcement with stainless steel mesh is placed.

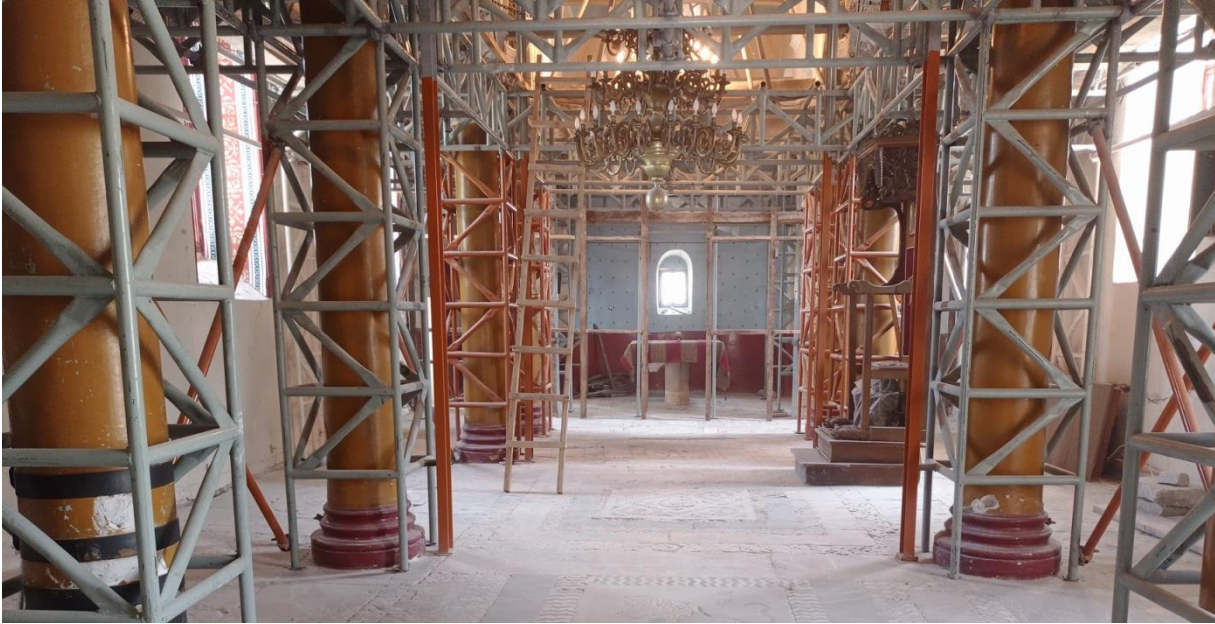
Columns and Pillars

The arches of the temple are supported by monolithic columns and two pillars inside the sanctuary.

The main failures of the pillars and columns of the temple are:

- The marble columns of the outer narthex of circular bisection are in good condition.
- The columns of the central part of the temple, which have circular bisection, built by stone and plastered, present a variety of pathology with shear, flexural and capillary cracks, while this pathology reaches in many cases up to their marble base.
- The columns in the sanctuary area of rectangular bisection, built by stone and plastered. They show shear and flexural cracks.

- The deformation of the north and south walls has dragged the columns along and they now show a deviation from their original position. It is necessary to form a stable foundation field of the columns so that the columns can now successfully receive the loads. This will be achieved by constructing a **reinforced concrete perimeter beam** at the base of the columns.

- It is recommended to install **metal rings** on the stainless steel columns along their entire height, taking into account the cracks of the columns. Between the stainless reinforcements and the stones of the column, grouting is carried out with Albaria Inezione and the entire reinforcement system is covered with plaster, so that its final image is that of a monolithic element.

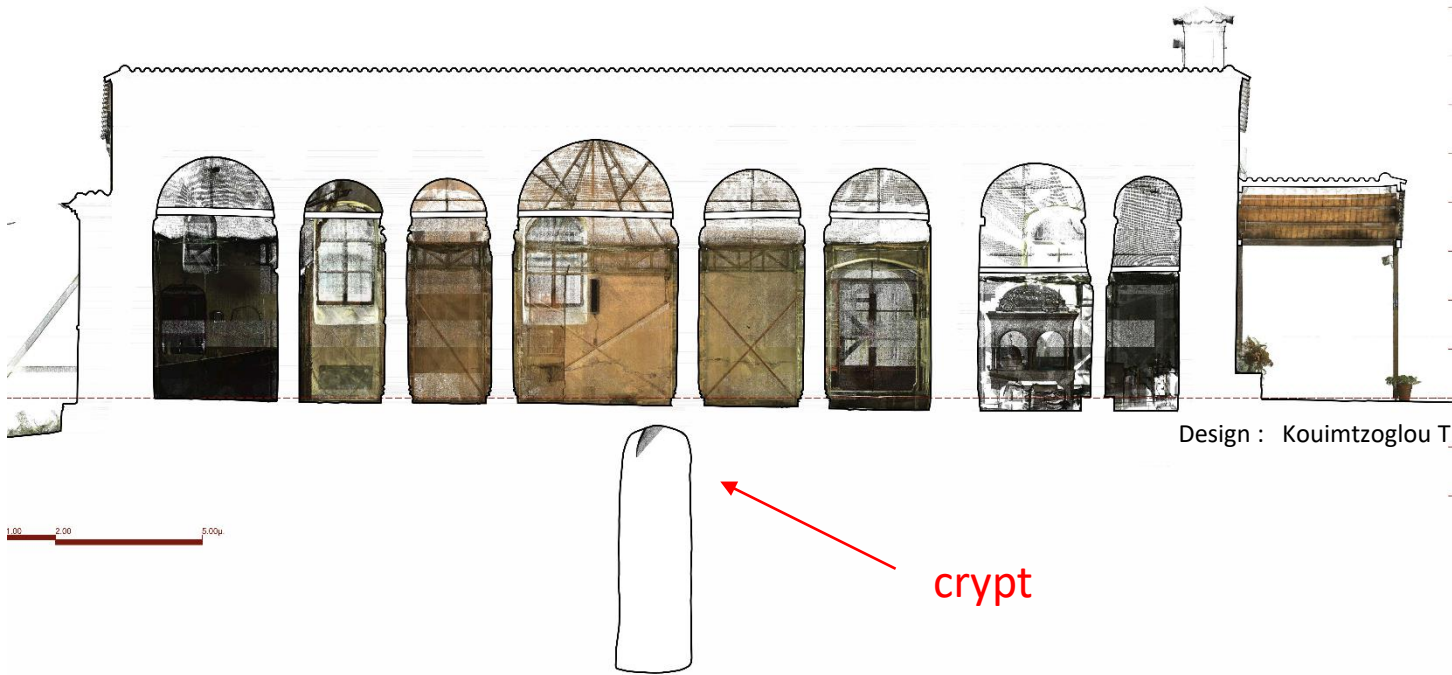
Floor

The floor of the temple shows significant deformations, cracks and loss of material. Approximately in the middle of the temple and towards the south wall, a hole has been drilled for the study of the underlying hatch. At a depth of 6m below the position of the episcopal throne, two underground spaces were explored, on the south side of which a vaulted crypt begins. These underground spaces also contributed to the subsidence of the temple.

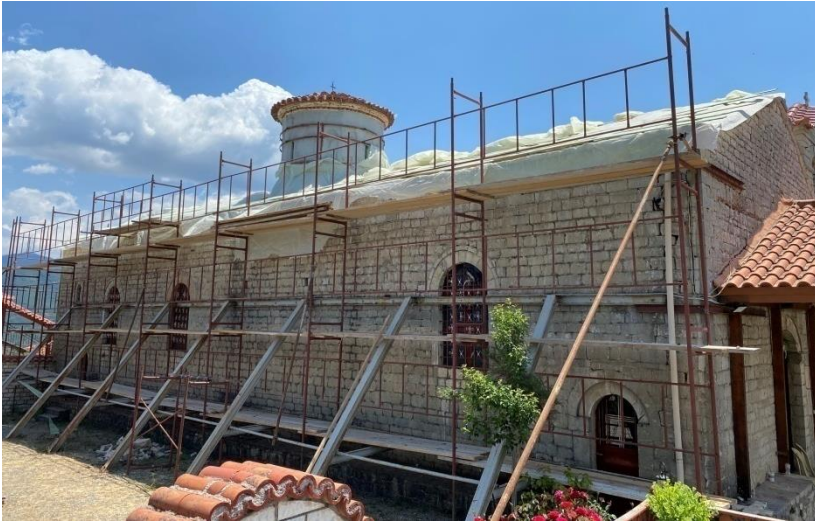
The choice of stonework outside the Katholikon, degrades the aesthetic value of its interior, the floor of which is a presumption of its high art.

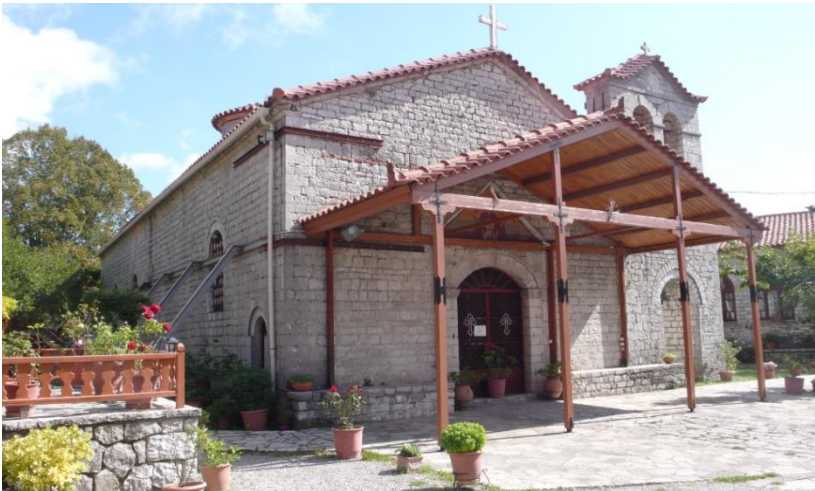
Also, a burden on the overall perception of the monument is the modern wooden shed, west of the narthex, which changes the proportions of the temple and makes it difficult to perceive its historicity.

Removal of modern wooden shed, west of the narthex

- The removal is chosen, because it changes the proportions of the Catholic and makes it difficult to perceive the degree of its historicity. Thus, the entrance to the temple and the triangular mosaic representation of the Virgin Mary will be more clearly visible.

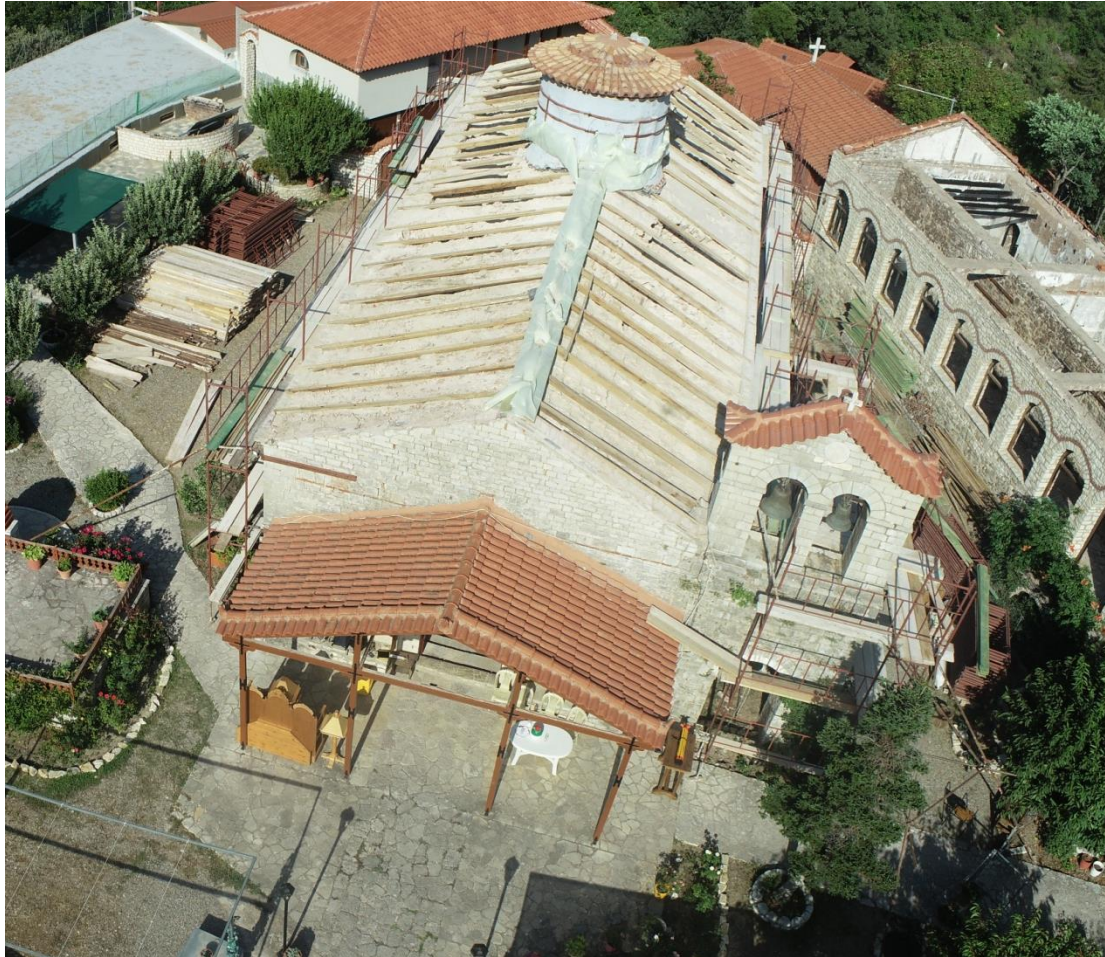
Reinforcement of bell tower

- The bell tower of the church is in generally good condition. The main point of its pathology is the loss of the binding mortar, for the solution of which a new cleaning is proposed, joints on the entire surface of the masonry and grouts to homogenize the masonry.
