Interdisciplinary study for Varnakova Monastery Catholicon rehabilitation

Interdisciplinary study and rehabilitation project proposal

Varnakova Monastery Catholicon rehabilitation project

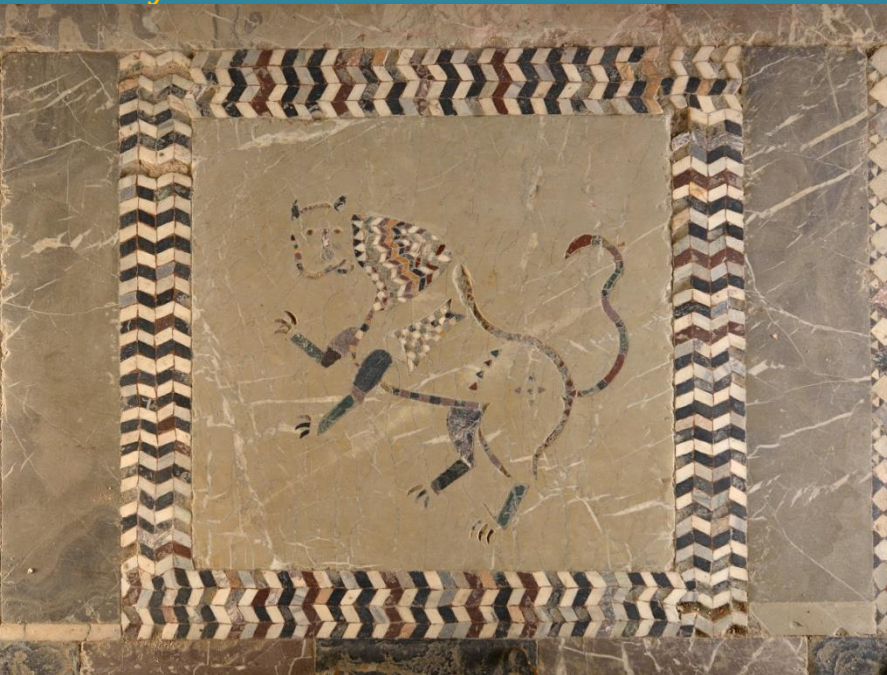
It preserves the **elaborate decorated 11th century floor**

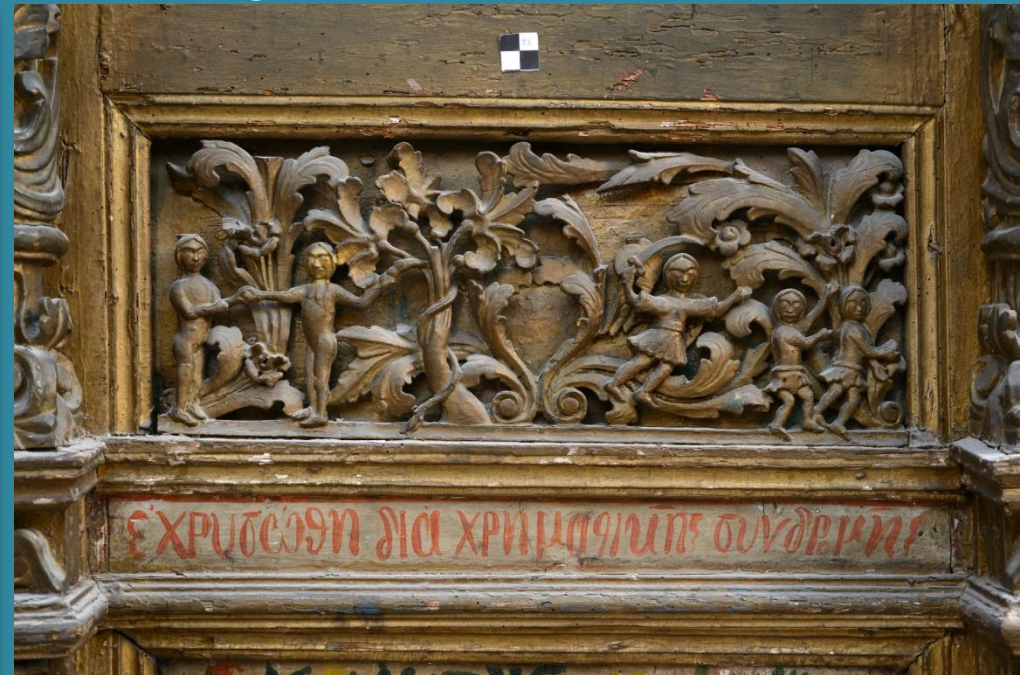
The **Templon** from the Kapodistrias reconstruction is also of high historical and architectural value

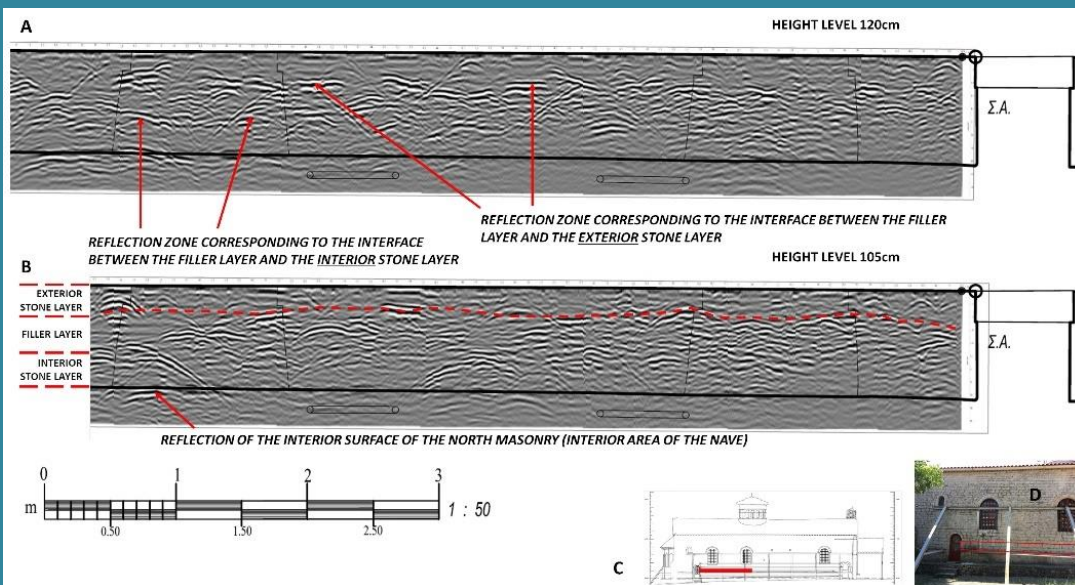
- ❖ Information regarding the extension and interconnection of cracks **within the internal layers of the structure.**
- ❖ Information regarding possible **detachment of the masonry layers.**

Three-leaf masonry: (i) Exterior stone layer (25 cm), (ii) Intermediate filling layer, (iii) Interior stone layer (25 cm)

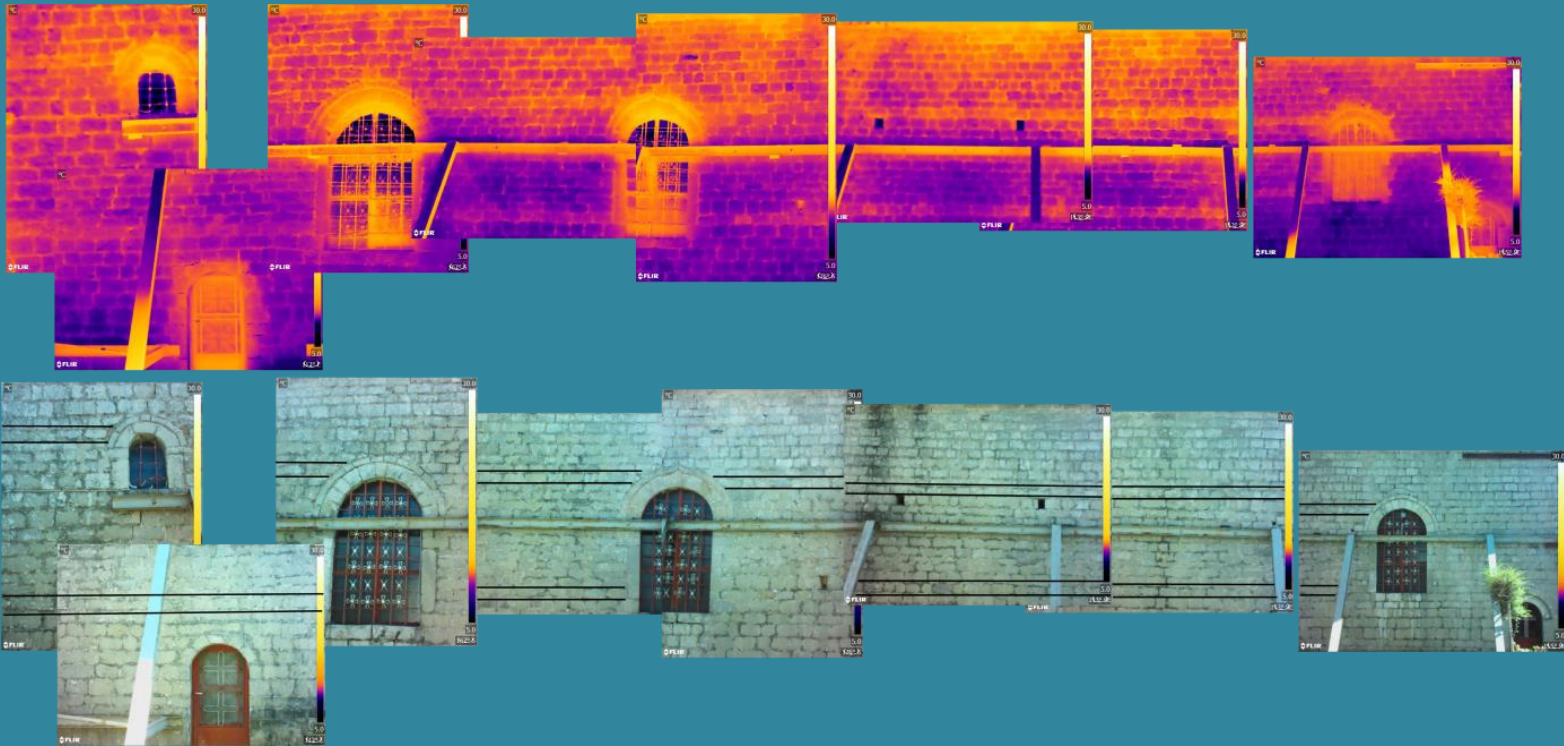
Infrared thermography measurements indicated areas of **mortar detachment** (lower temperatures) and areas where **incompatible mortars** have been used locally (higher temperatures), while it also revealed the presence of a (possibly wooden) **element surrounding** the structure in the internal layer.

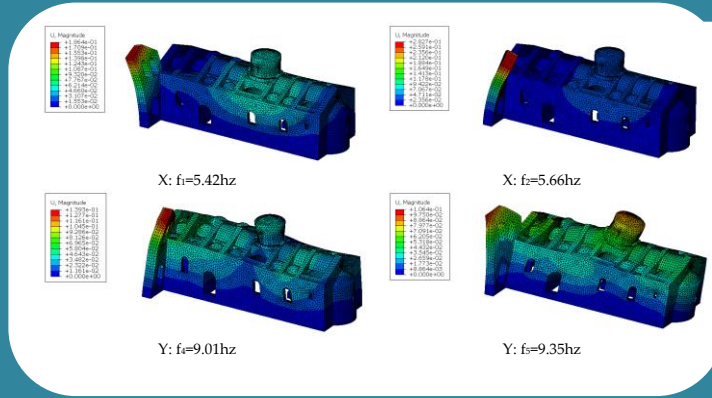
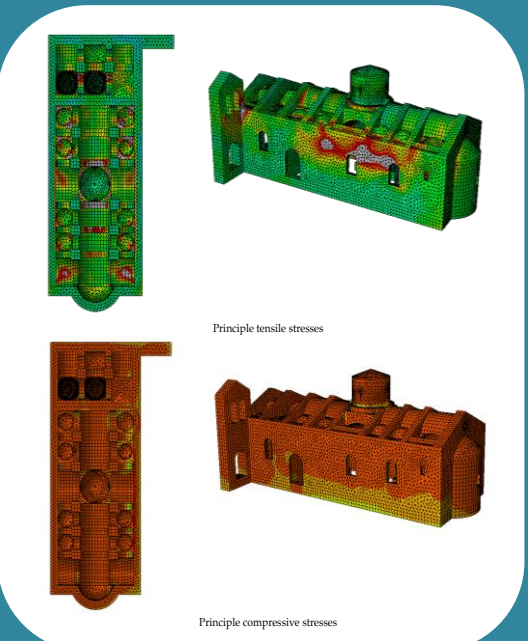
Fundamental frequencies and mode shapes

The Catholicon structure was modeled in the Abaqus 6.19 using **3D continuous solid elements**

SD limit state – mean values of principle stresses envelope

The examination of the current state provides information regarding the **vulnerability of the monument**, while analysis of different repair scenarios reveals the optimum solutions to reinstall structural integrity

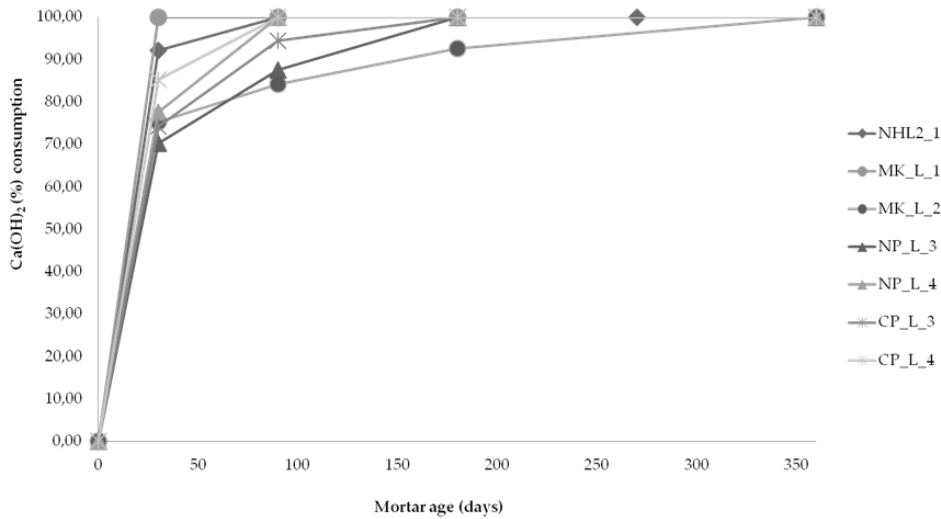
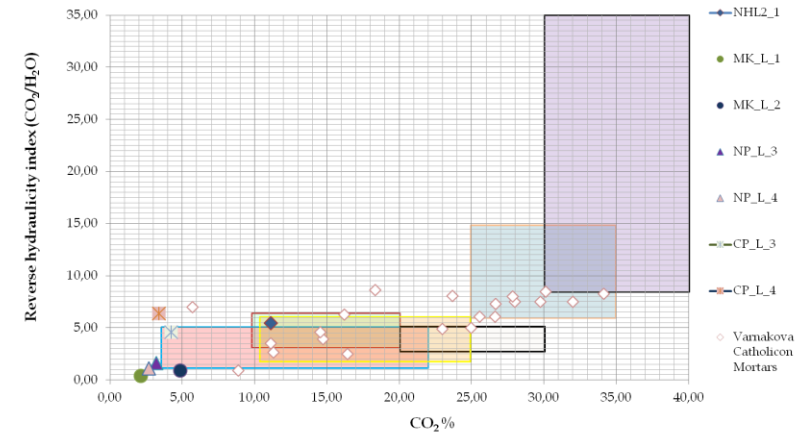
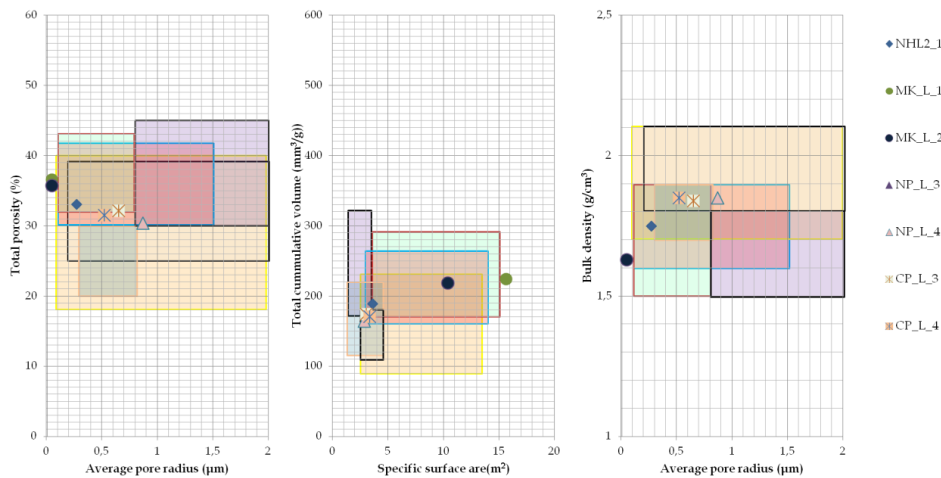
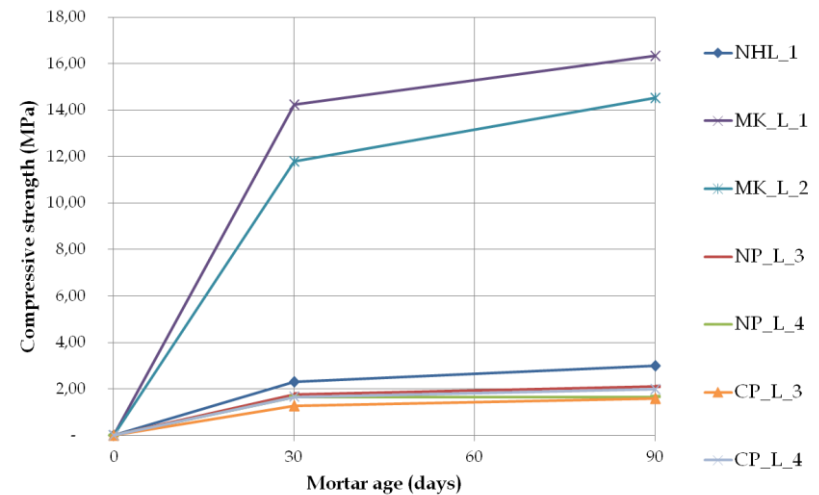
❖ **Lime-metakaolin mortars** present the **highest compatibility and performance**

❖ A commercial lime-metakaolin mortar (**M15**) was selected

❖ A lime-metakaolin based grout was selected for the grouting process

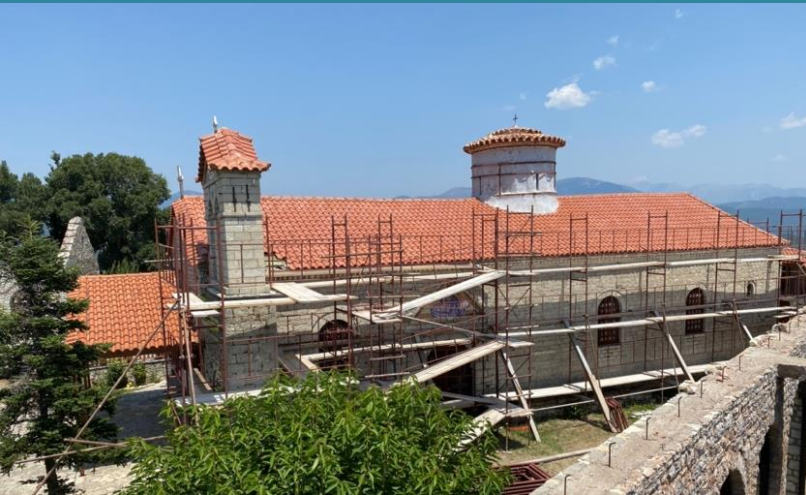
South side

Exterior scaffolding system of high safety and resilience

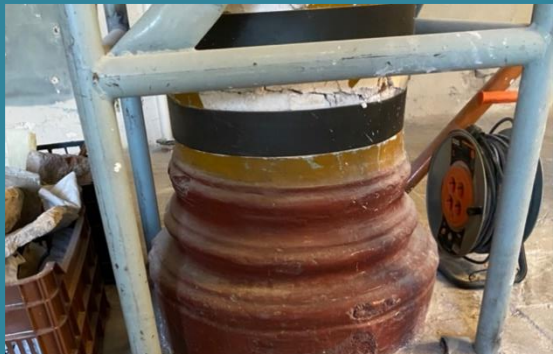
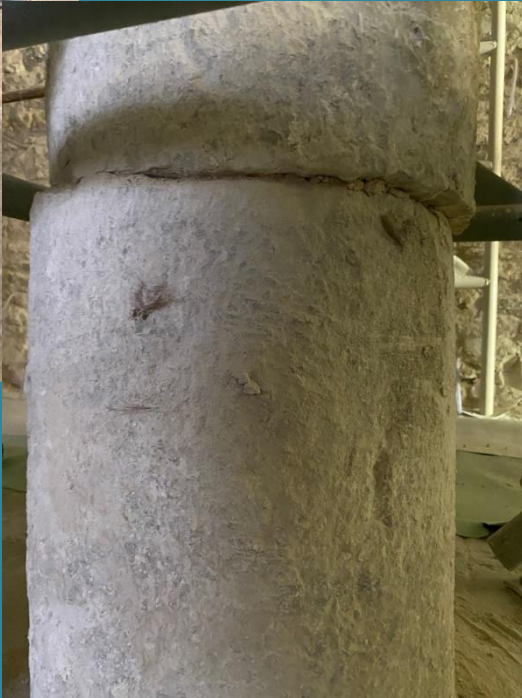
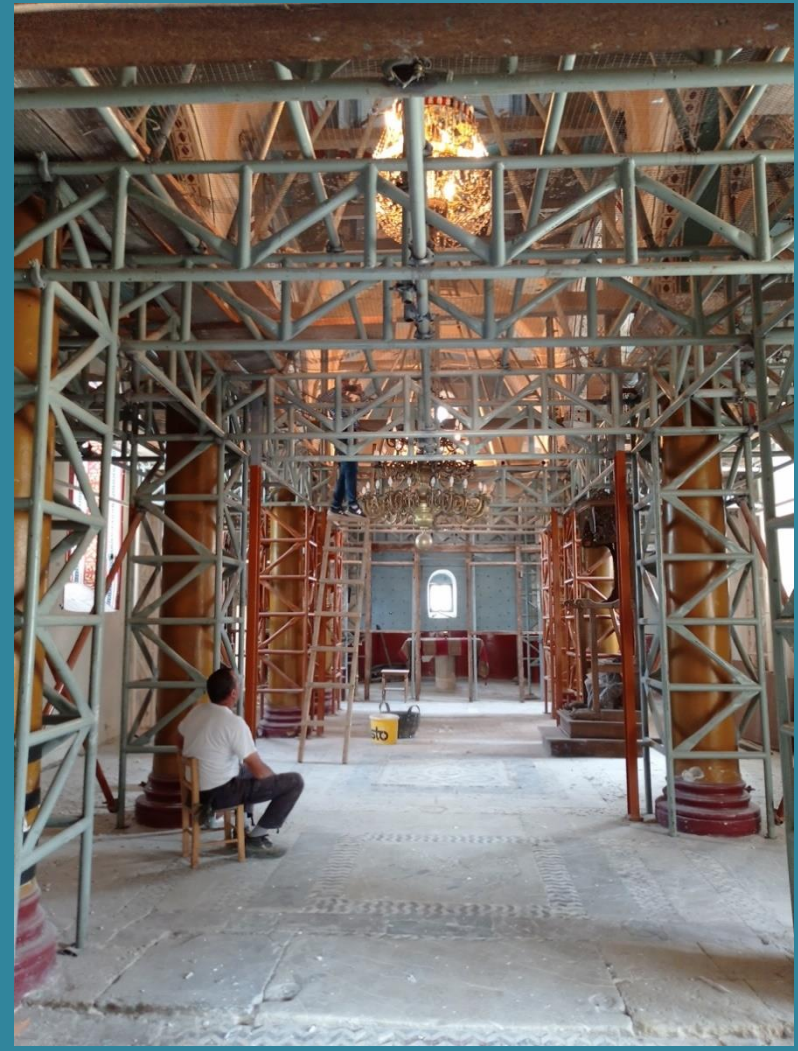
Readjustment and reinforcement of interior scaffoldings

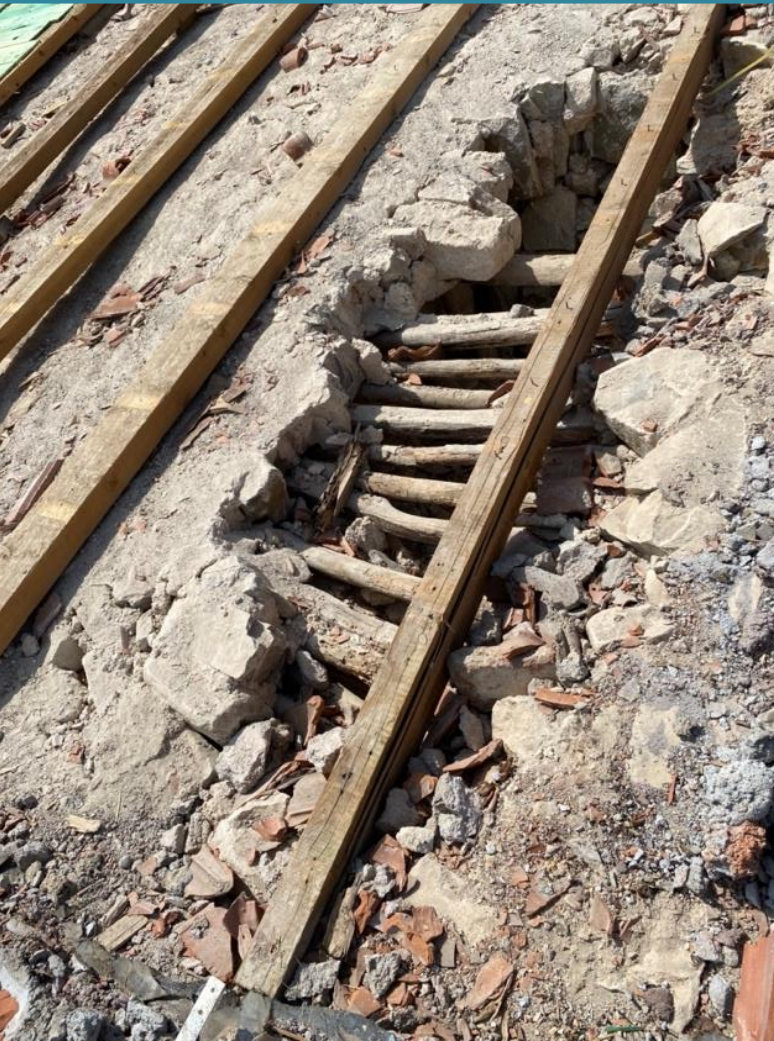
The roof was opened, revealing a complex system

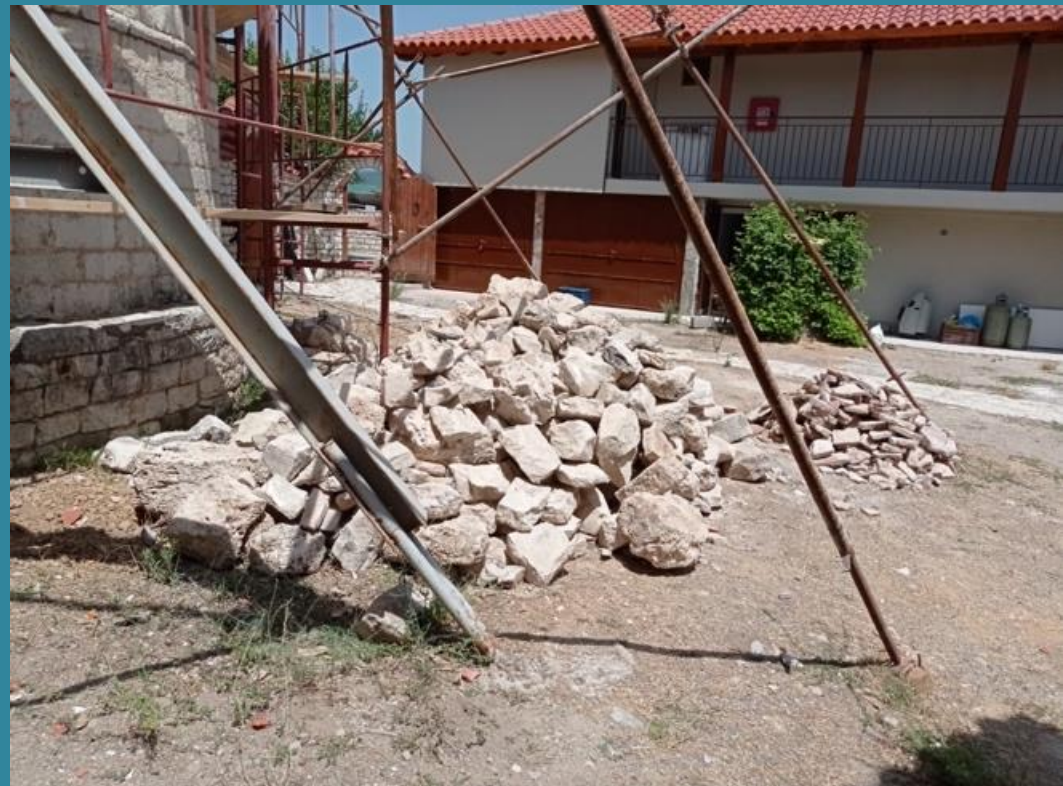
Stones and deteriorated materials were carefully removed (300 tons!)

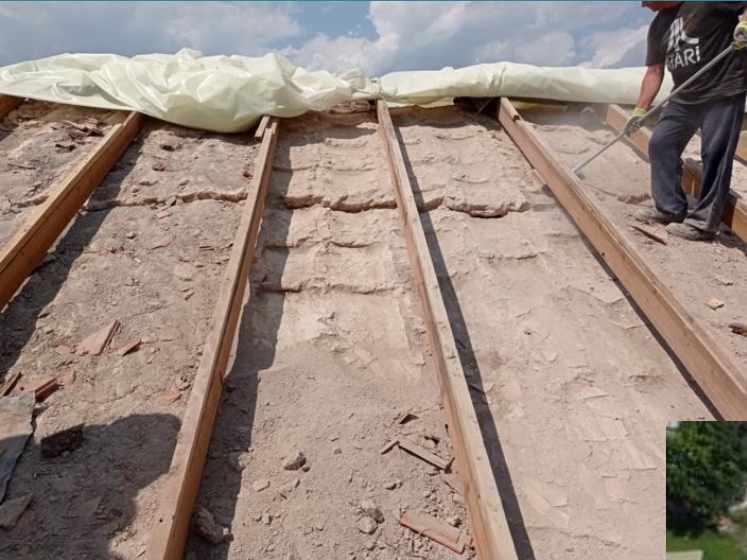
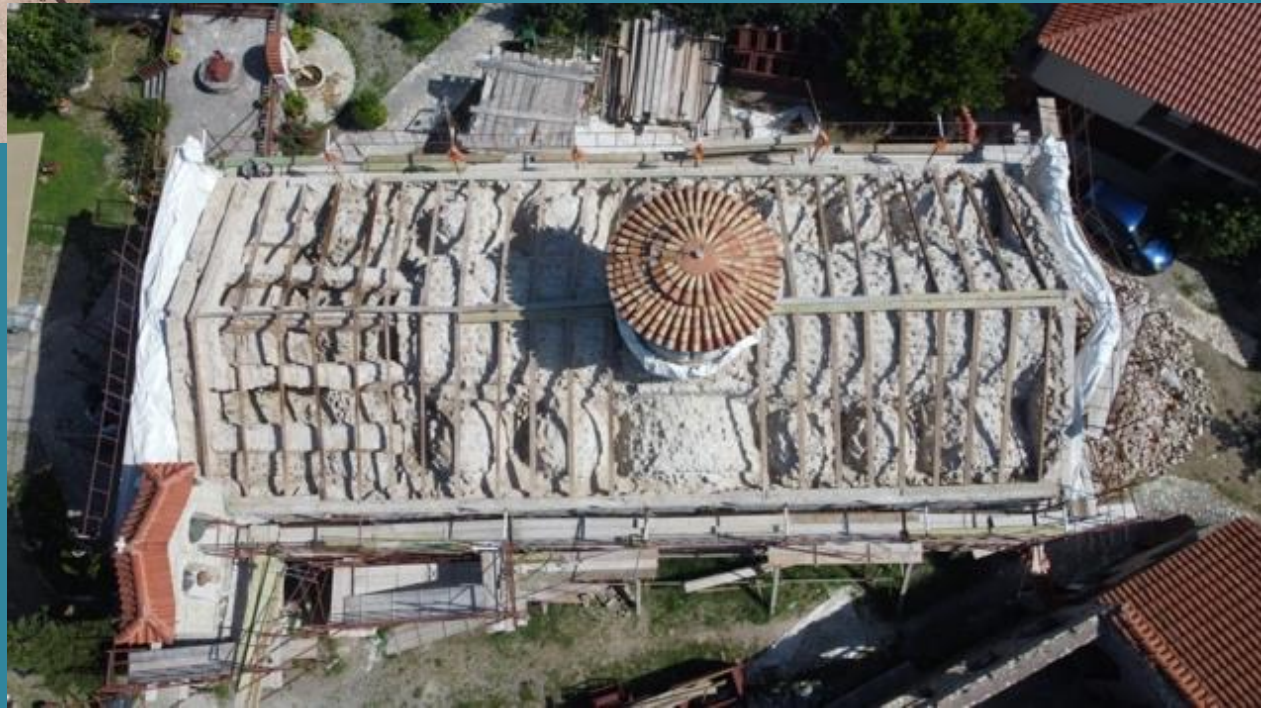
Over the Pronaos, traces of the original ceramic roof tiles were revealed

The underlying roof system was completely revealed and documented

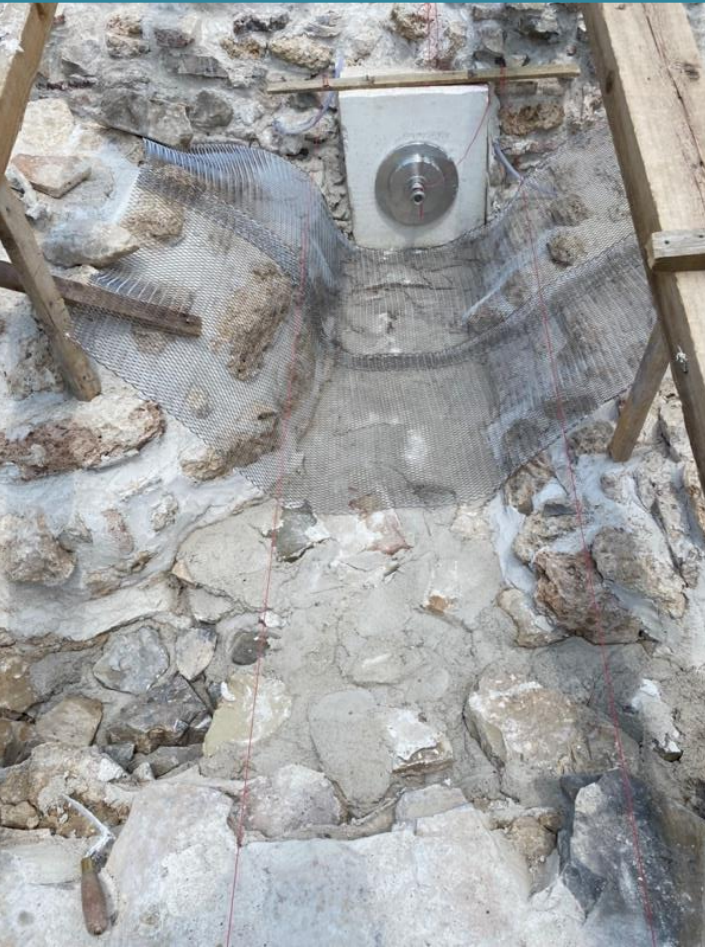
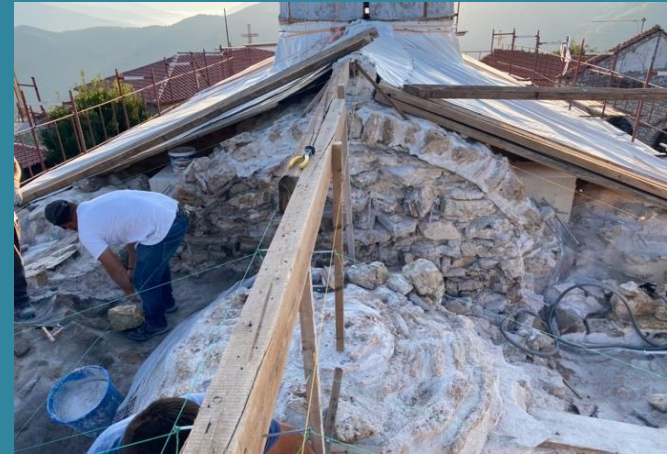
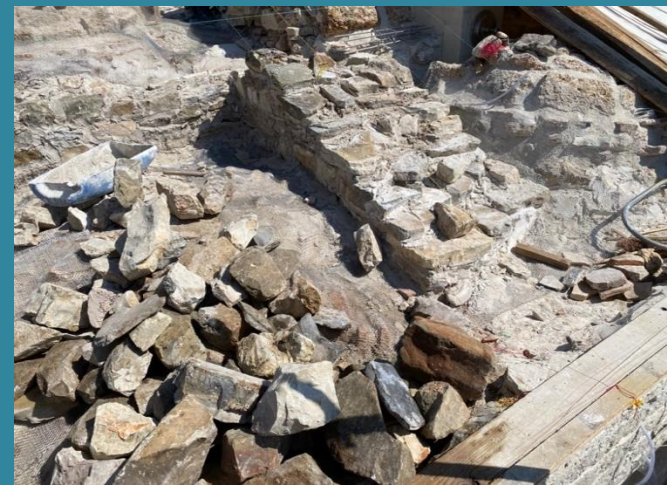
The works were carried out in stages, while reinforcing and grouting the supporting structures, where necessary.

Compatible Pozzolan concrete, stainless steel meshes and reinforcement elements and selected historic stones (only in good condition and after cleaning) were used in the reconstruction

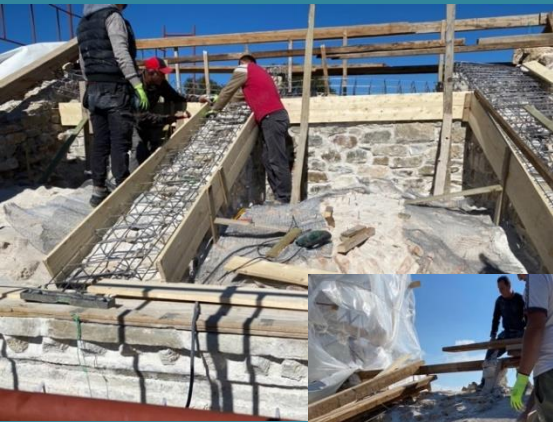
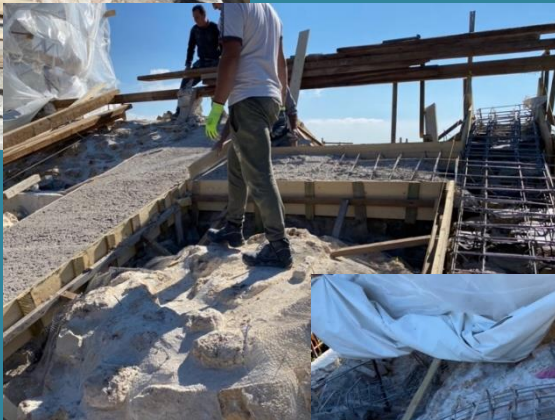
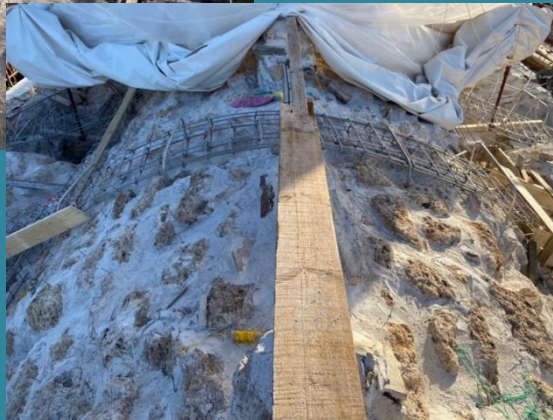
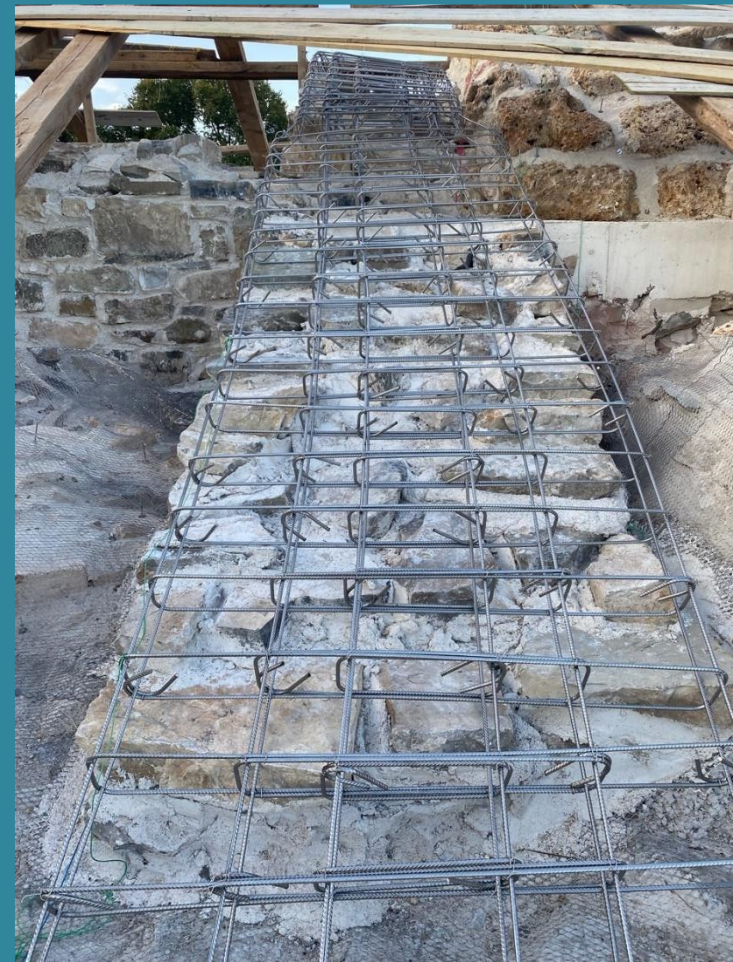
The works were carried out in stages, while reinforcing and grouting the supporting structures, where necessary.

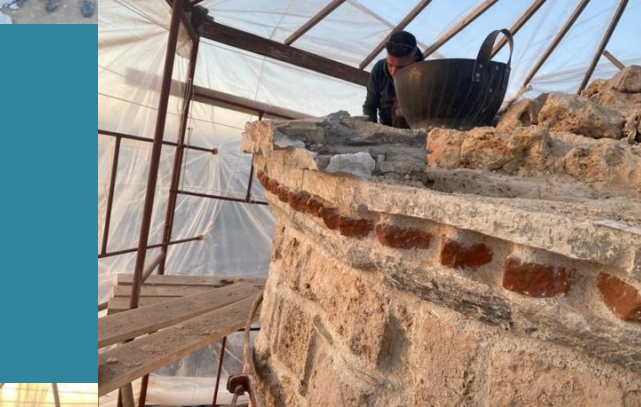
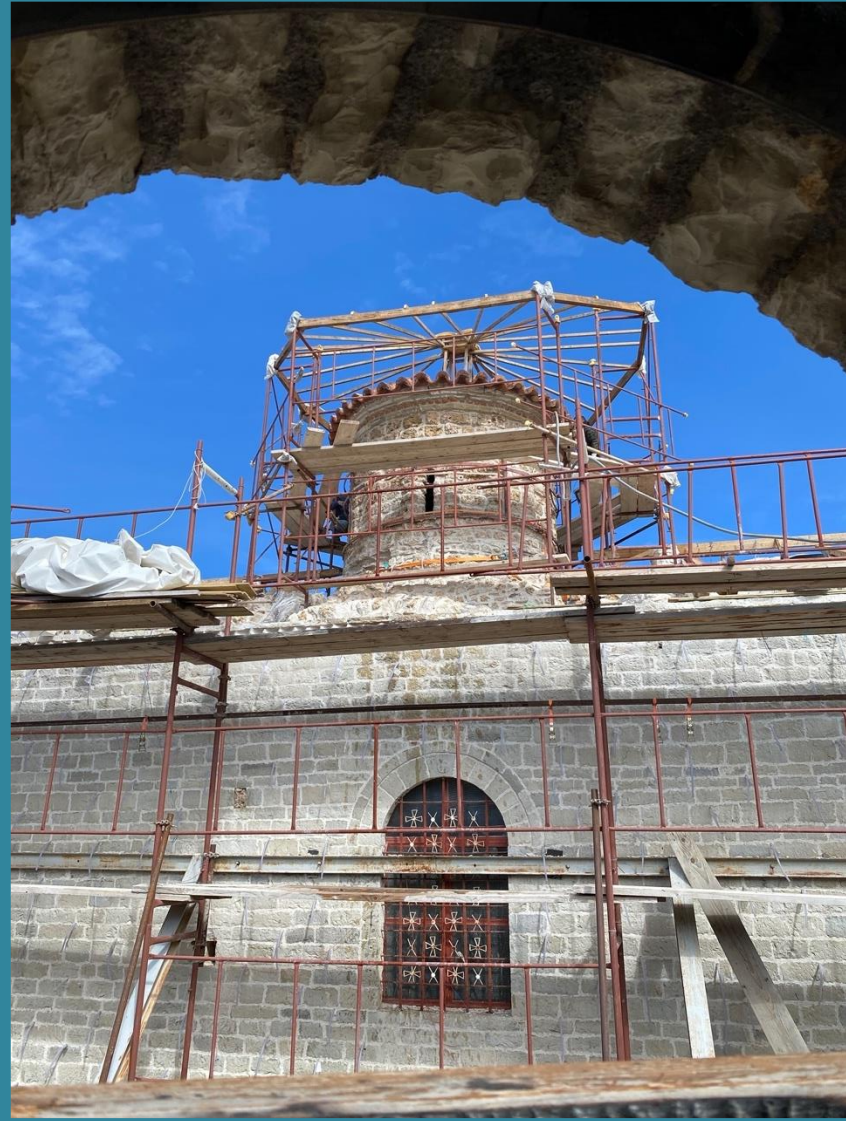
The main dome was restored, revealing and highlighting the authentic ceramic design and removing later additions

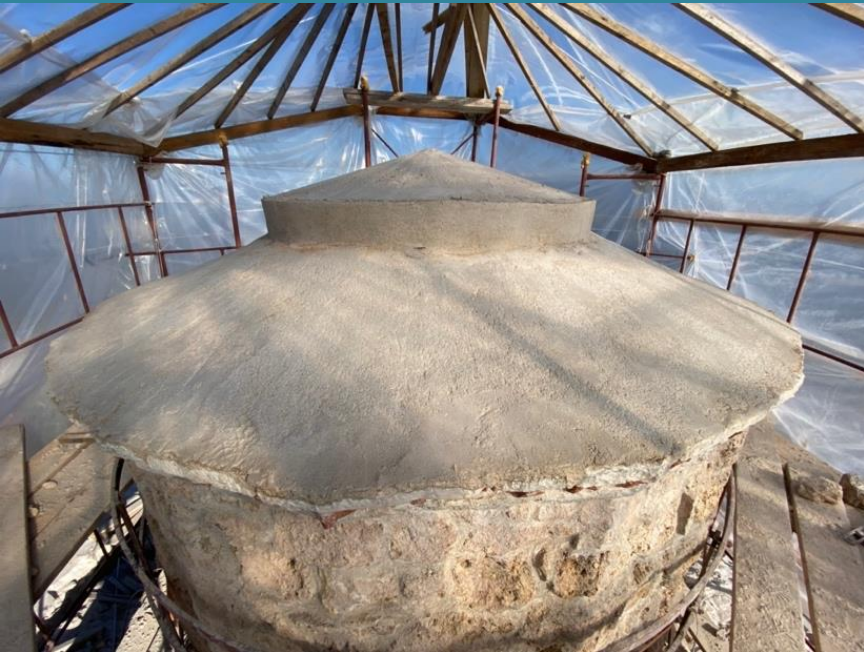
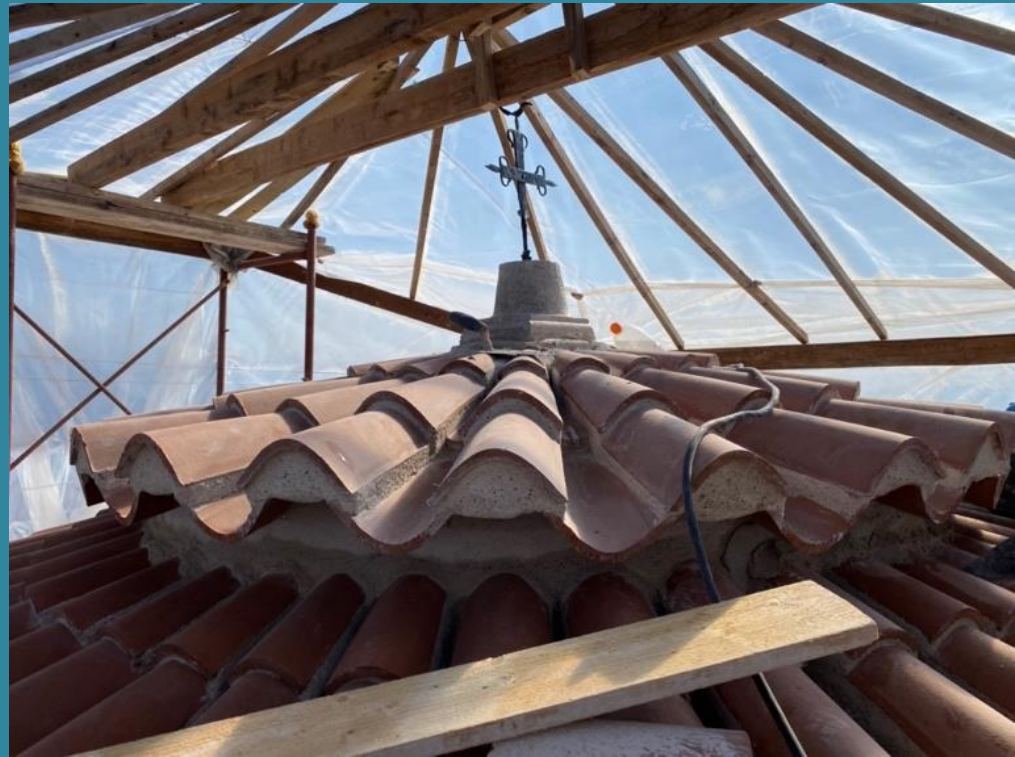
Finally, after the ceramic tiles were readjusted the original cross was repositioned

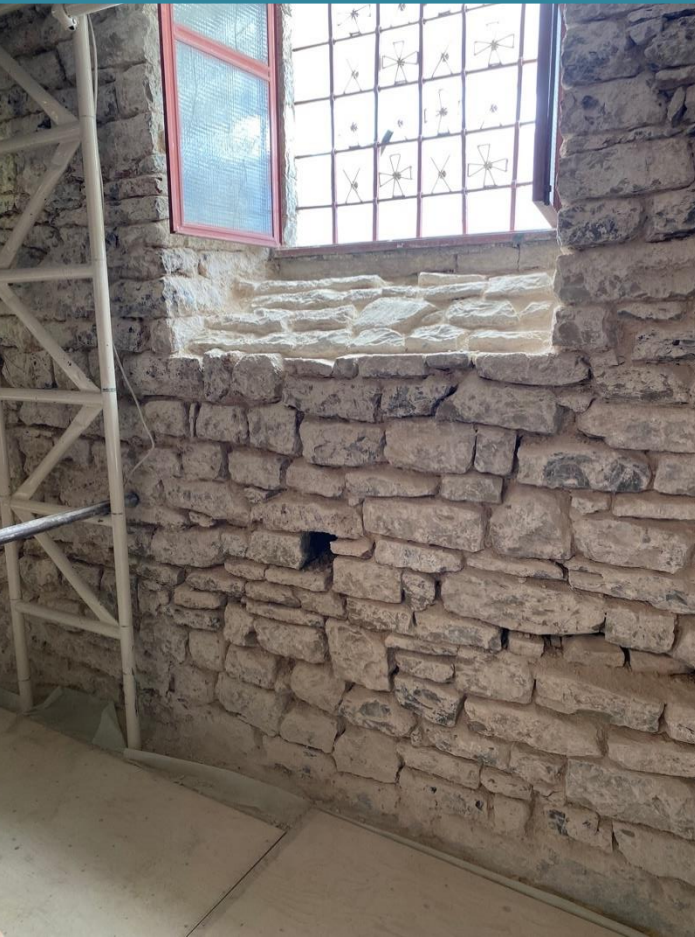
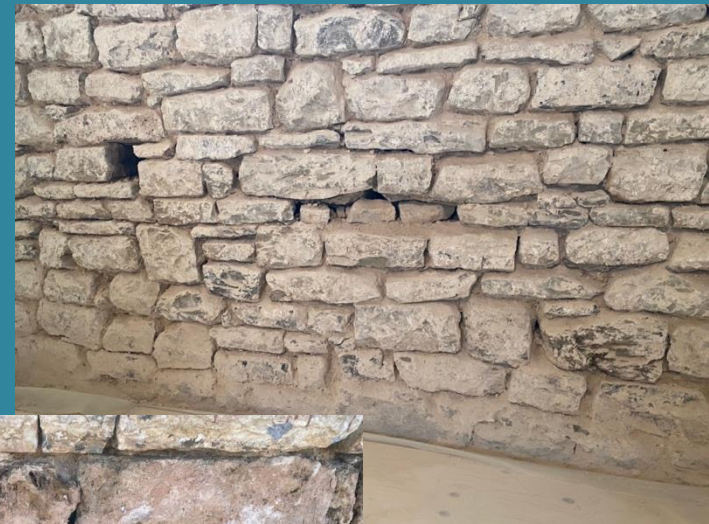
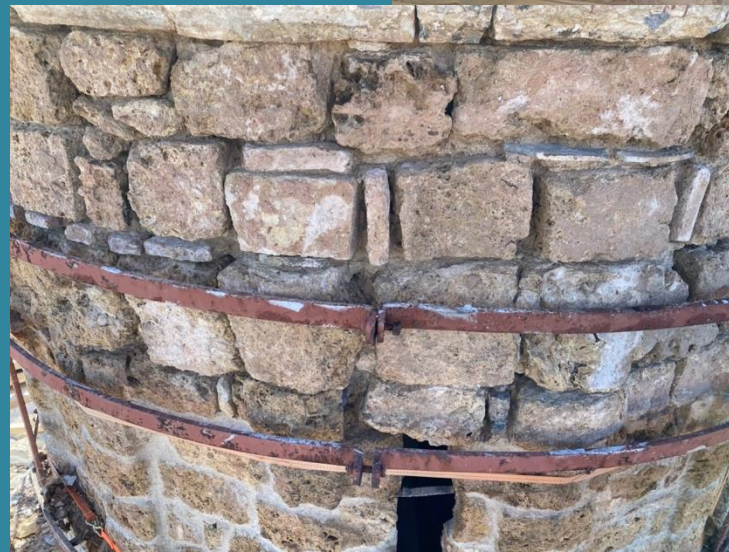
The masonry was cleaned of newer and loose plasters and mortars, highlighting the stone masonry system

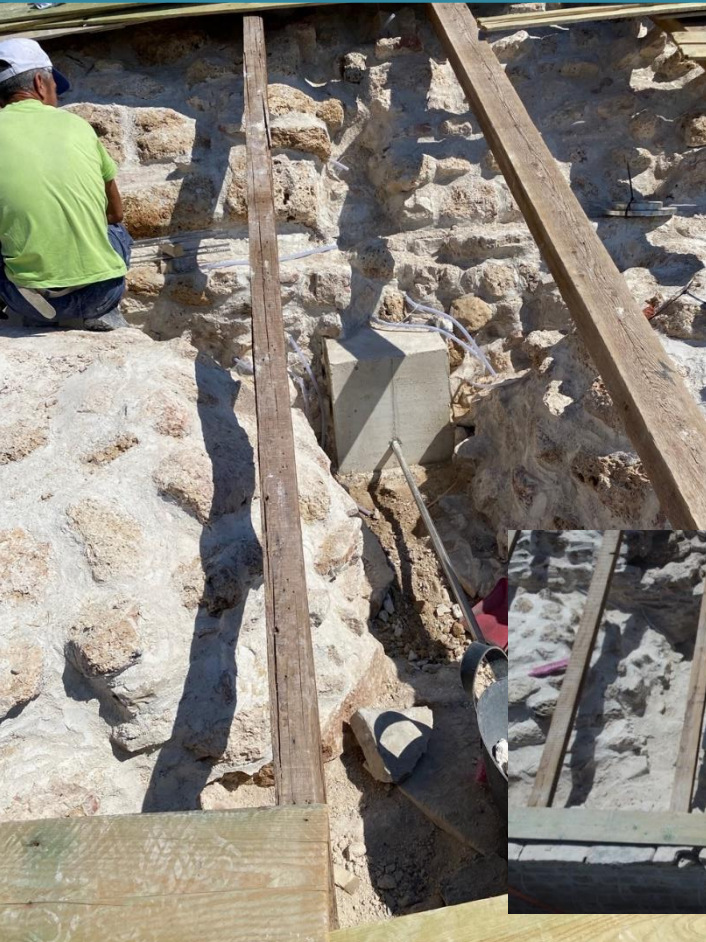
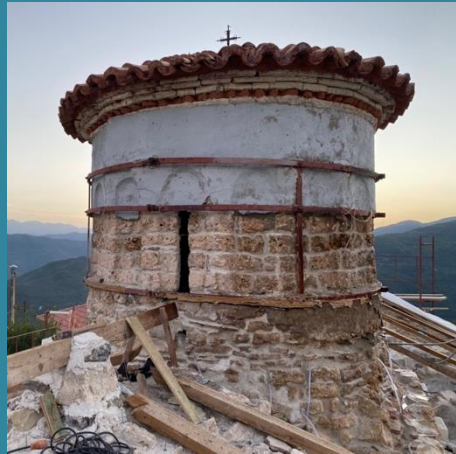
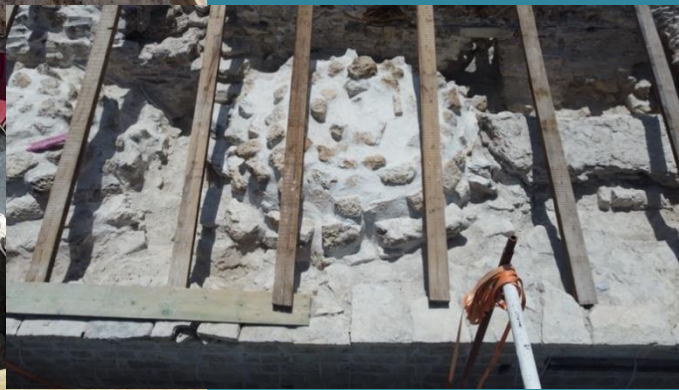
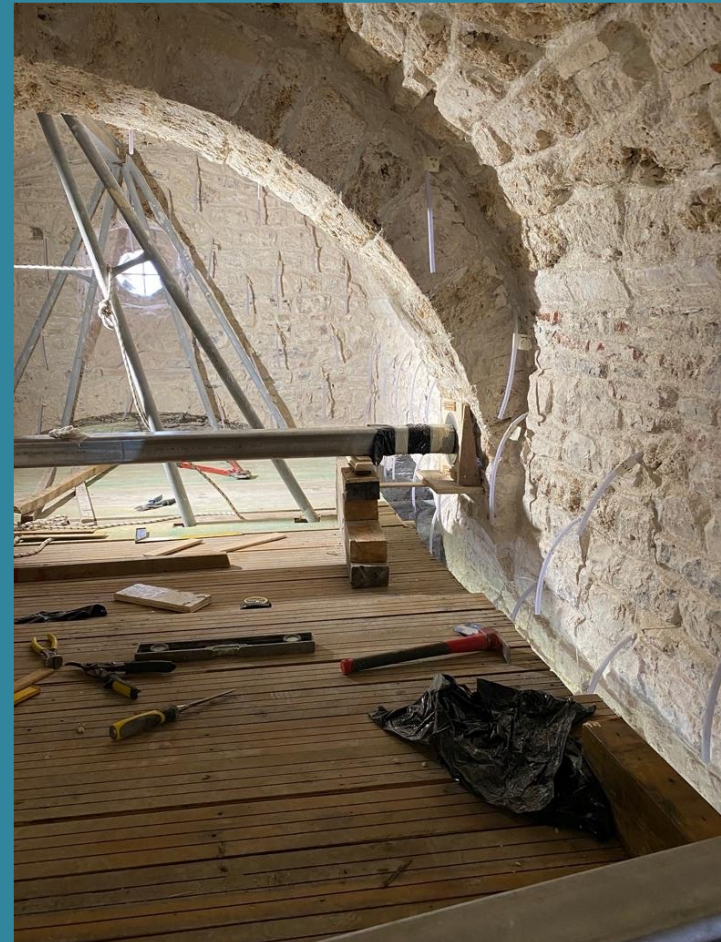
The masonry was repointed both regarding the exterior and the interior, as well as the dome and roof systems

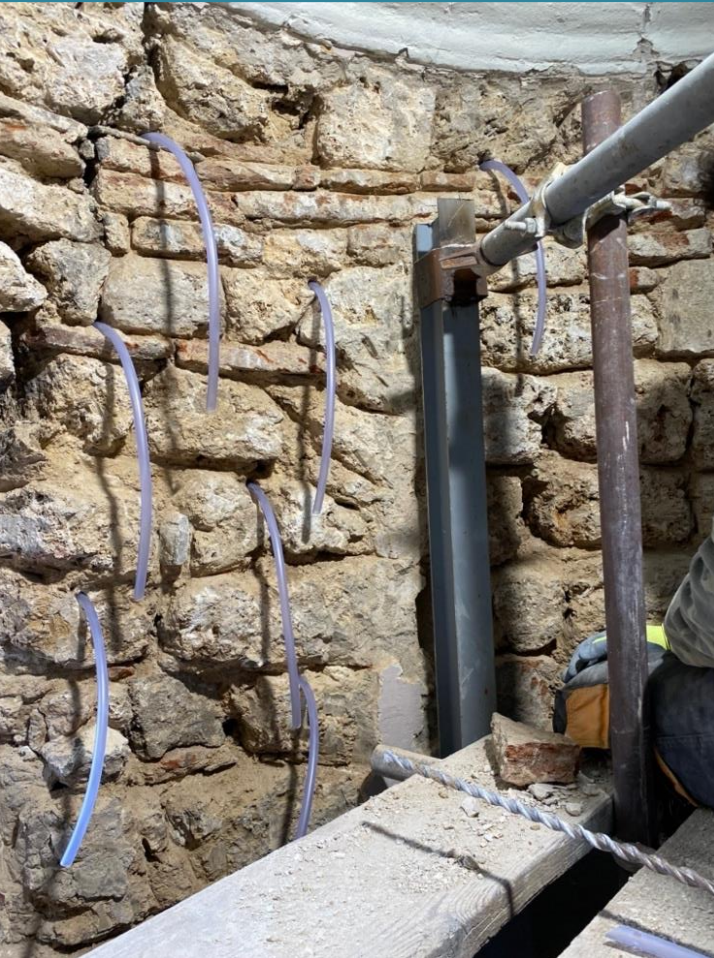
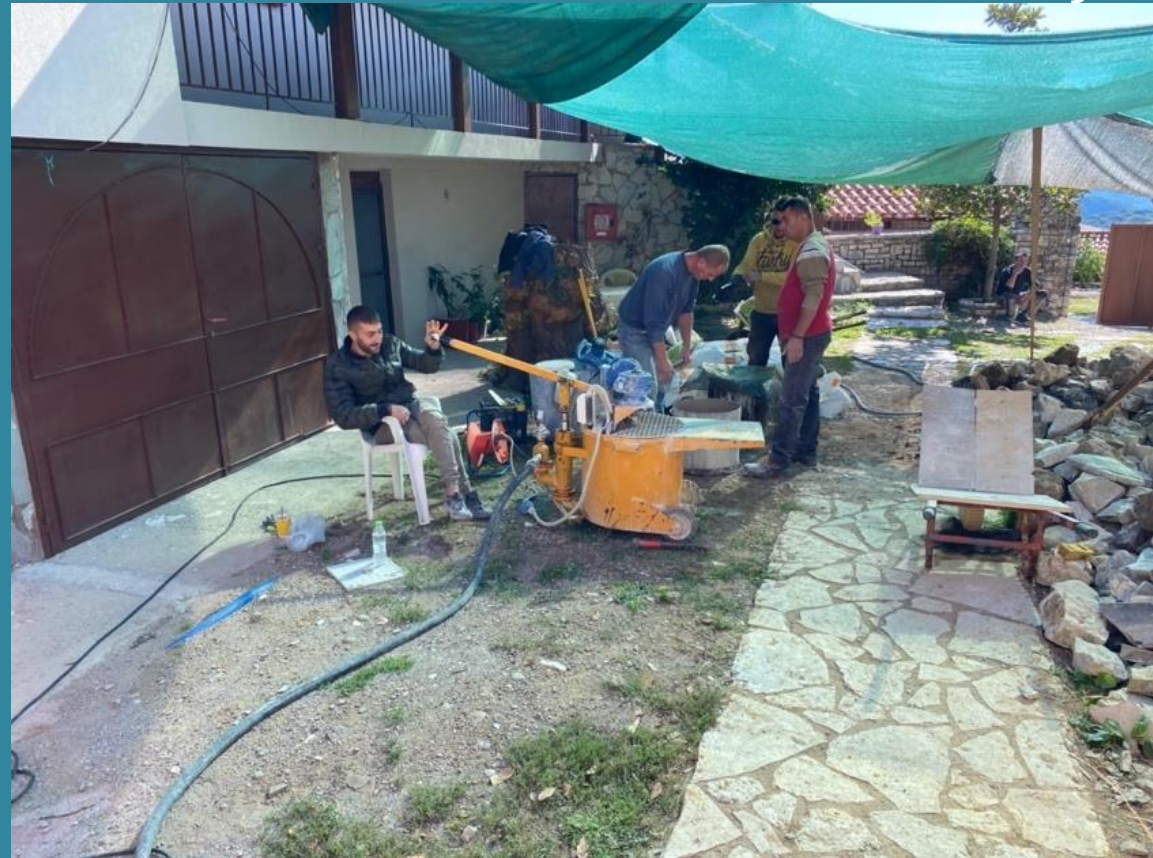
Grouting was conducted, from lower areas to higher areas to reinforce the structure (6.500 injection grouts were installed)

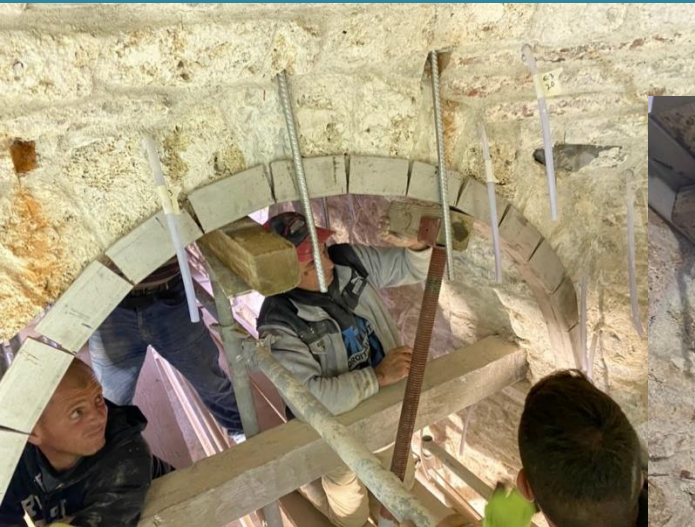
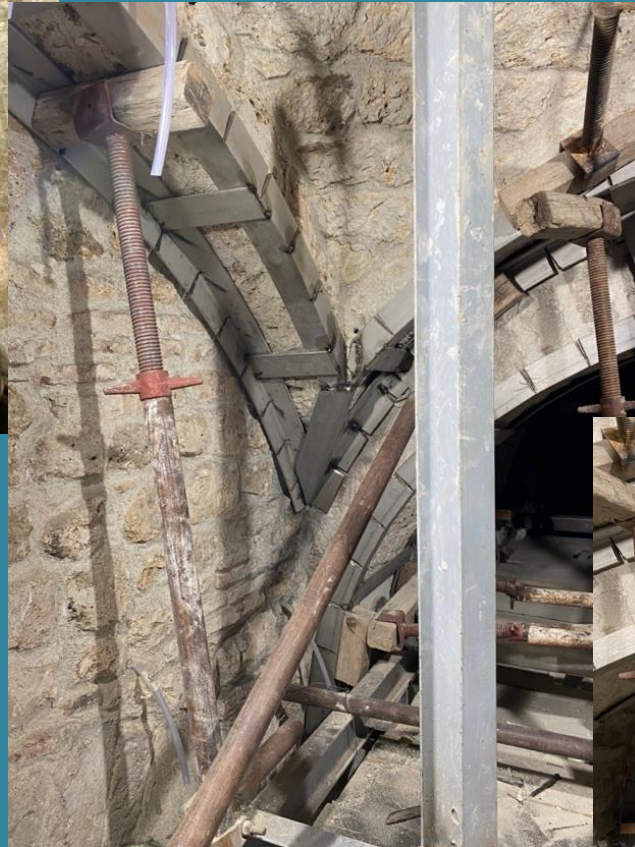
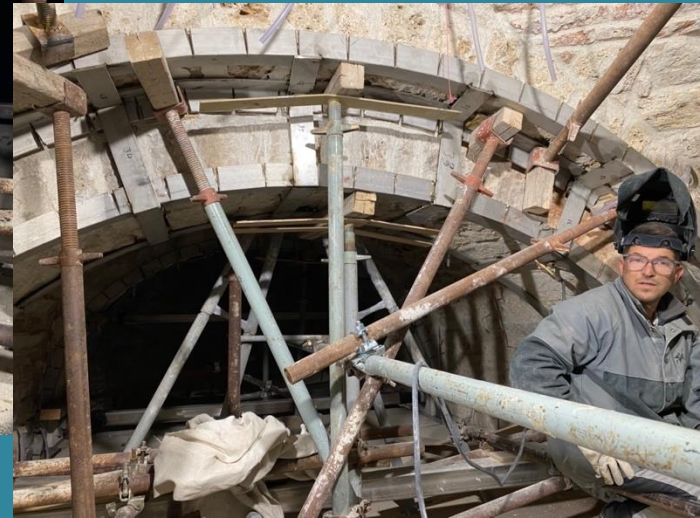
The arches were reinforced with stainless steel elements
