Interdisciplinary study for Varnakova Monastery Catholicon rehabilitation

Interdisciplinary study and rehabilitation project proposal

Varnakova Monastery Catholicon rehabilitation project

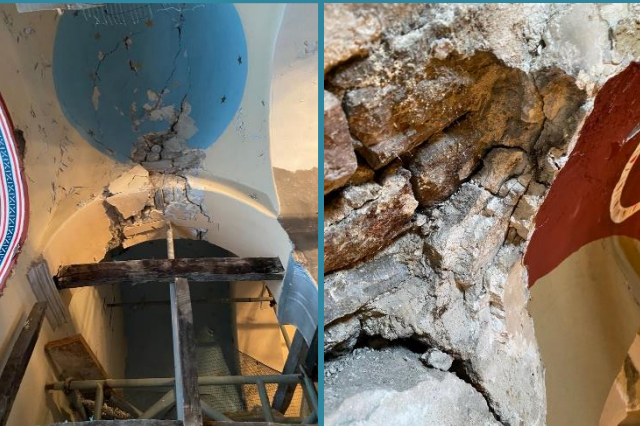
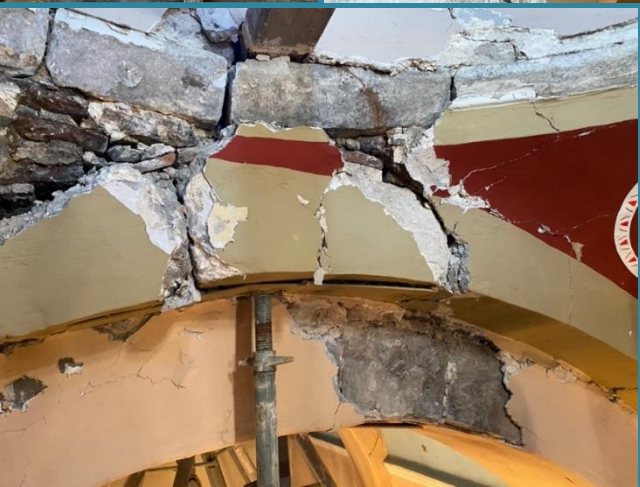
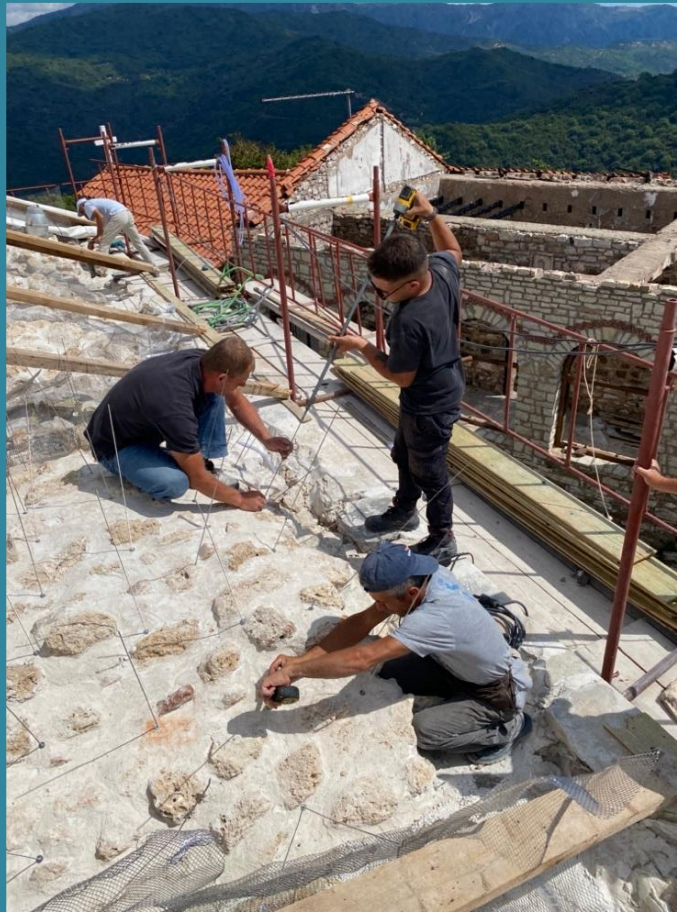
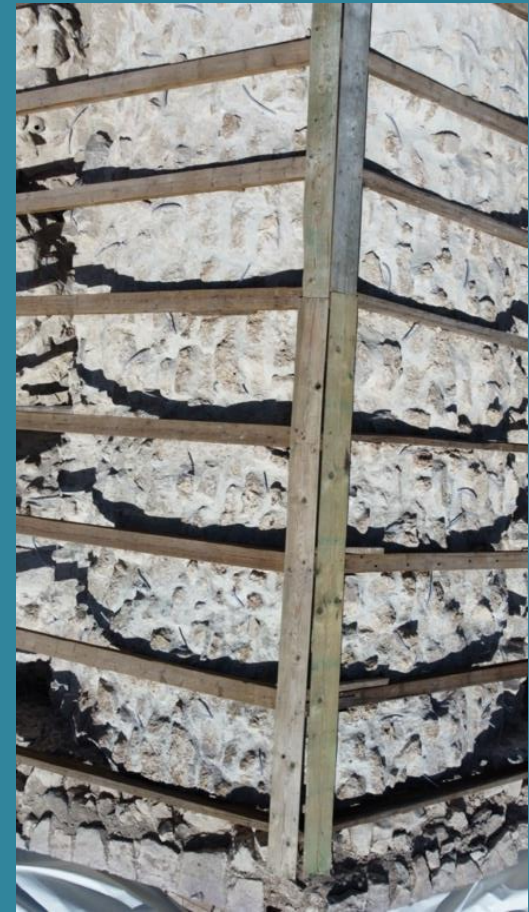
Dome and vault systems are restored, repositioned, repointed and reinforced, both internally and externally

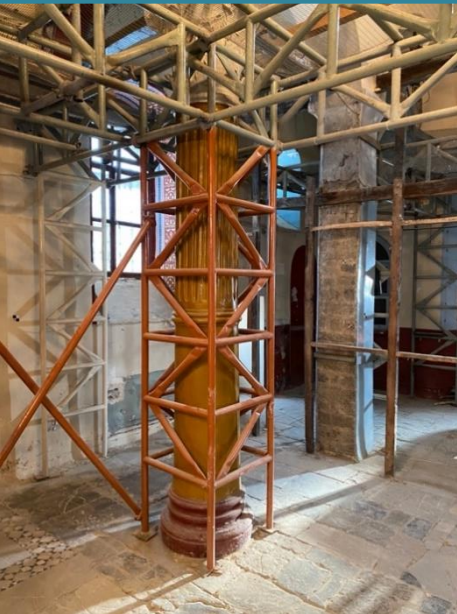
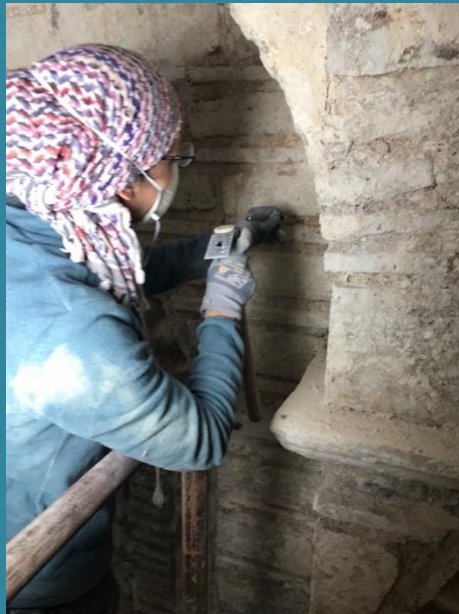
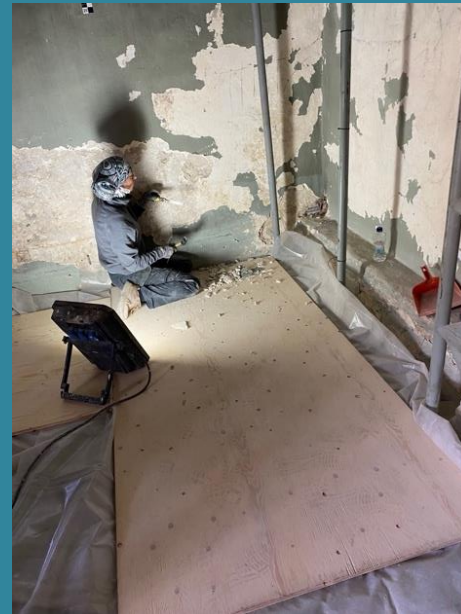
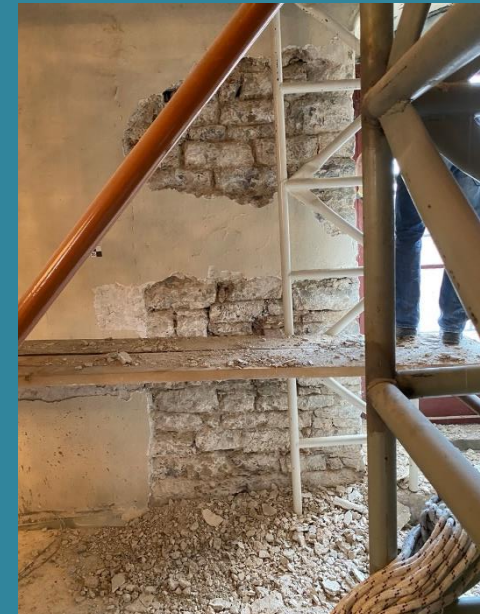
The presence of plasters was fully documented and they were carefully removed in order to investigate the possible presence of wall paintings beneath the different phase layers

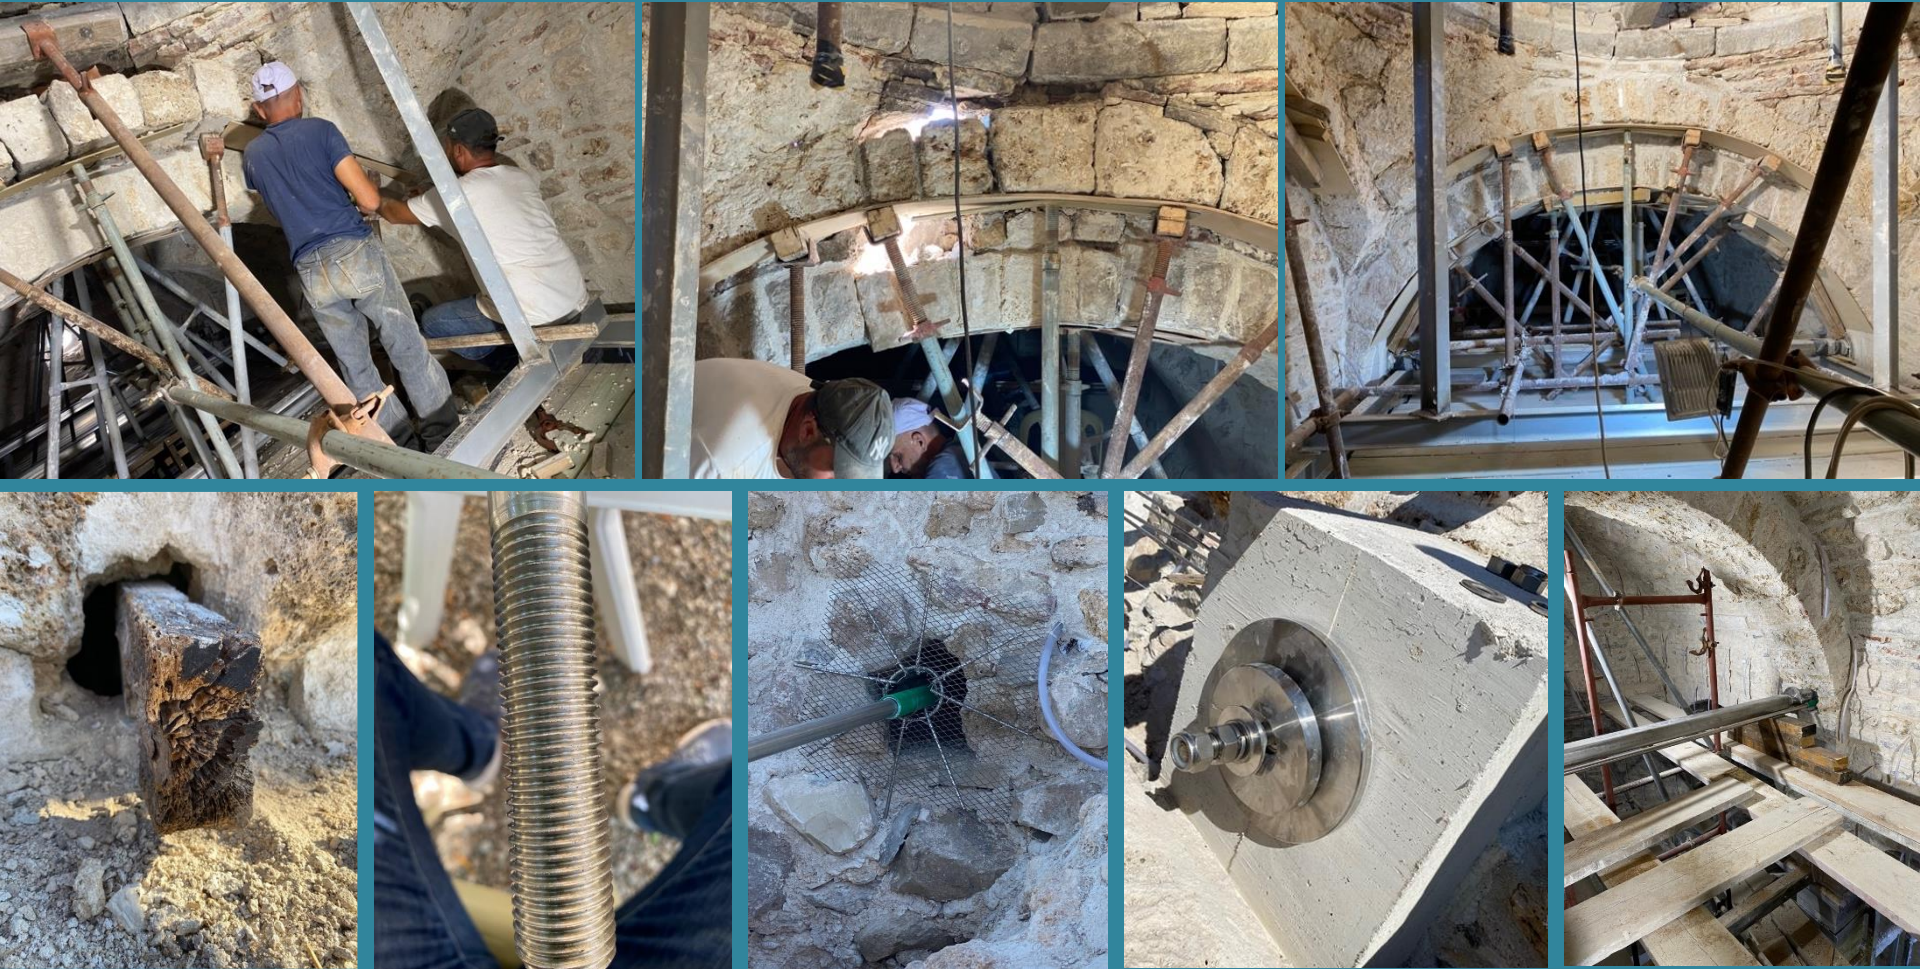
16 arches were reset

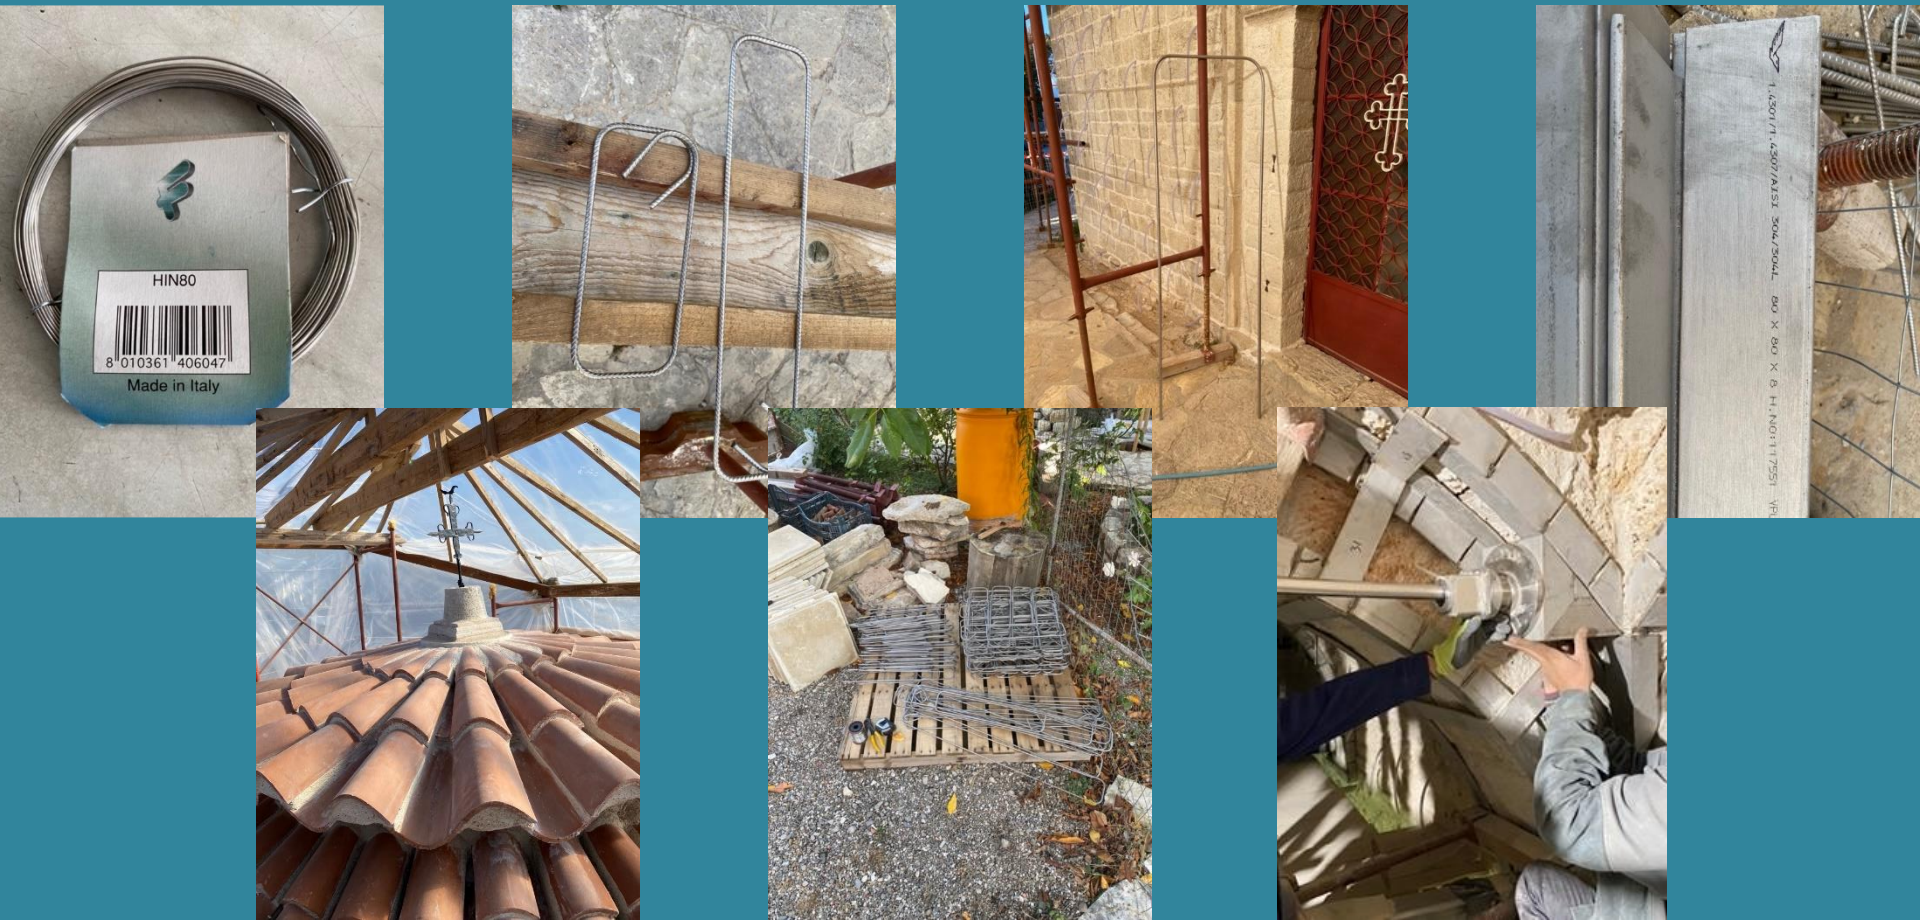
The materials used for the restoration works were continually **assessed** throughout the project and, if needed, **readjusted**. The aim is always to achieve **compatibility, performance and durability** in a case to case manner

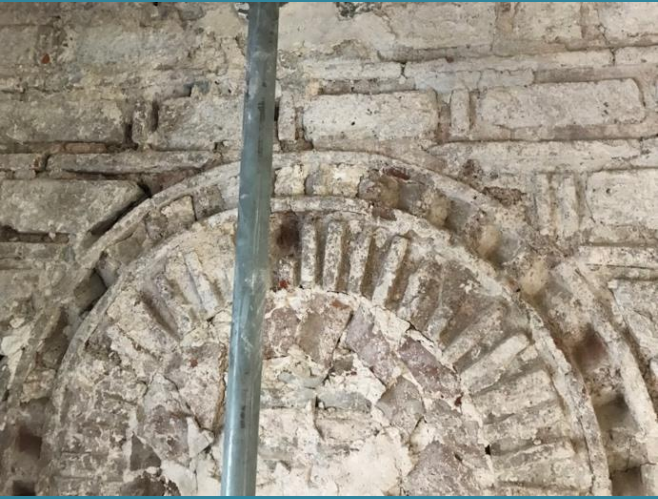
Byzantine masonry construction

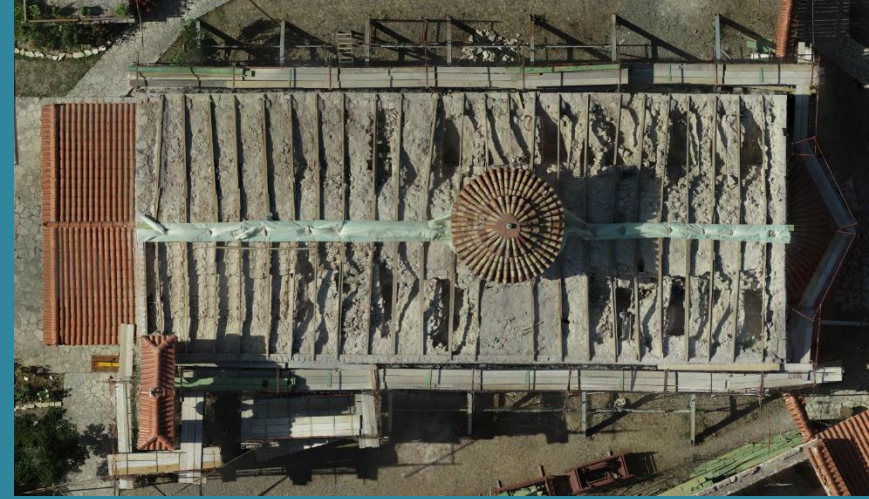
Removal of cement tiles

Documentation of roof system

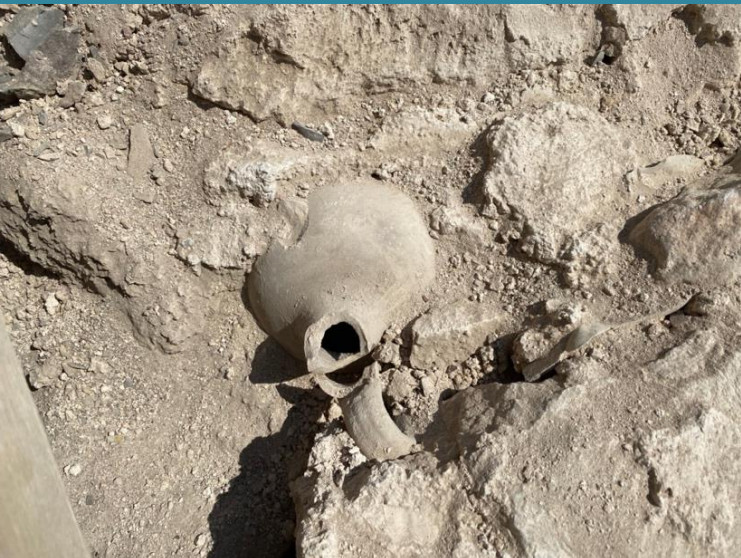
Ceramic jugs in the dome to enhance acoustics

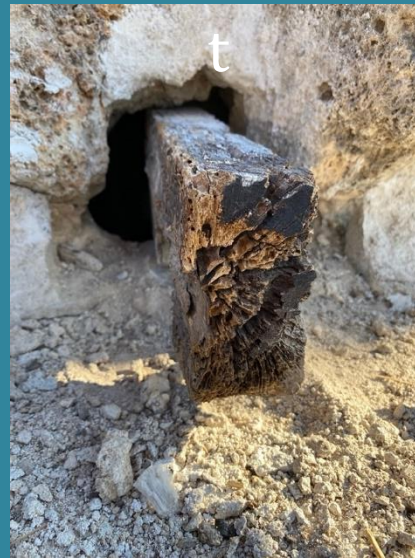
Wooden reinforcement

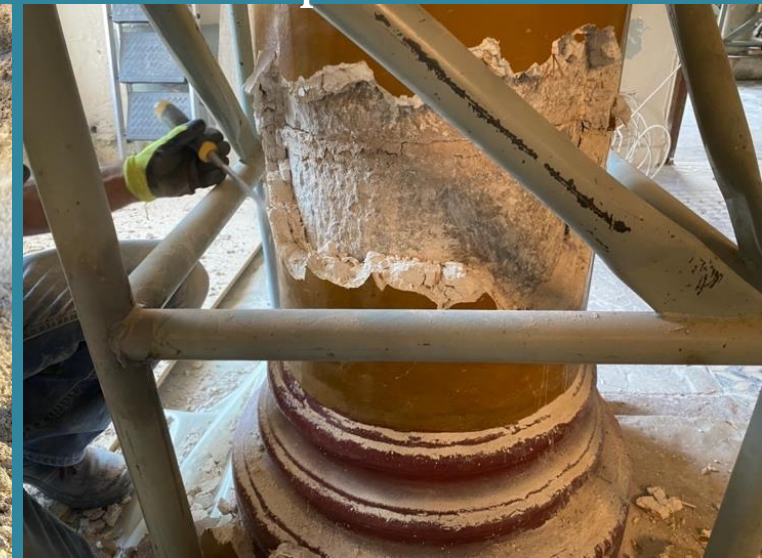
Stone pillar behind plaster
