THE ALEXANDRIA HANDS-ON WORKSHOP: CONNECTING THE NTUA HOLY AEDICULE EXPERIENCE WITH THE HRIAC EXCAVATIONS AT THE SHALLALAT GARDENS

Hands-on methodology of Non-Destructive Testing for the Protection of Monuments

Dr. E. T. Delegou¹, Emer. Prof. A. Moropoulou²

EDICULA: Educational Digital Innovative Cultural heritage related Learning Activities

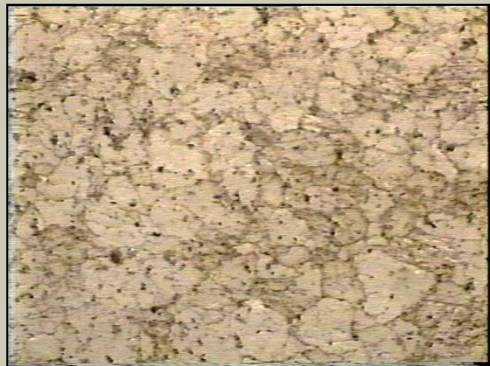
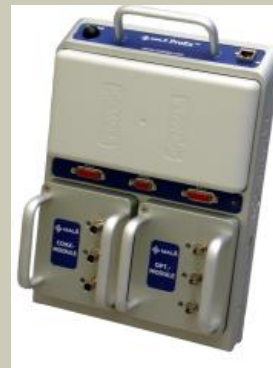
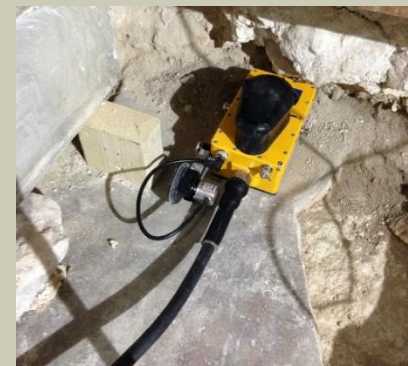
Digital Microscopy (DM): magnified visible spectrum images can be acquired, in situ or in lab, for the material under investigation. No treatment of the material is required.

Infra Red Thermography (IRT): Every material emits infrared radiation above absolute zero temperature. IRT measures the thermal variations of the material under investigation and produces an image. The IRT image presents temperature readings and their distribution on the examined surface by the rendering of different colors.

During **Ground Penetrating Radar (GPR)** measurements a short electromagnetic pulse (10MHz – 10GHz) is produced and propagated into the structure, part of the pulse energy is reflected (due to the presence of internal interfaces between materials of different dielectric constant), rendering a 2-D or 3-D image of the sub-surface. Results reveal internal structure of masonries, location of cavities, identification of detachments and internal cracks, assessment of decay depth.

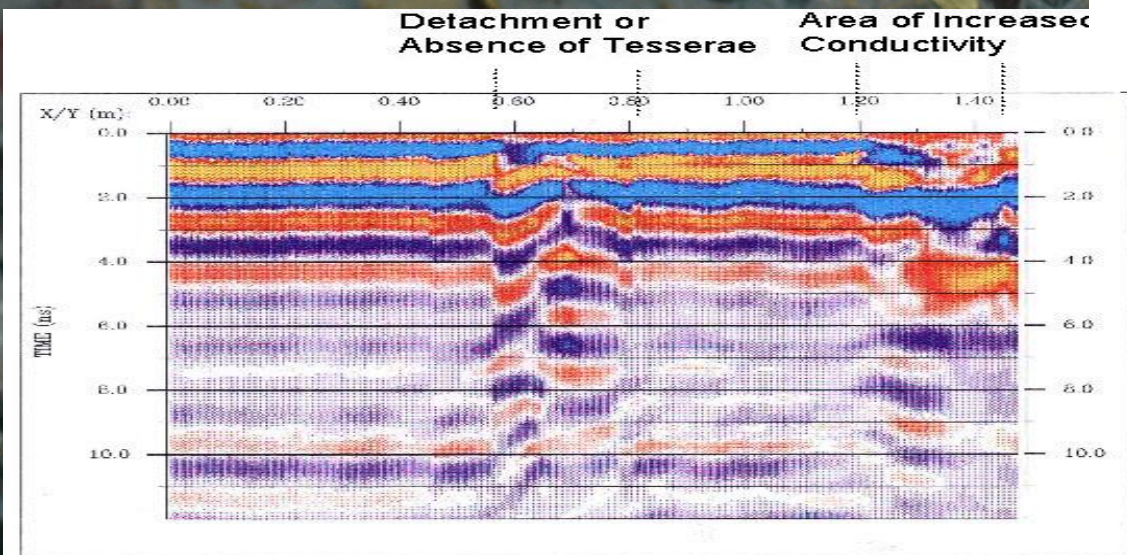
Coated Mosaic with Paint Layer
Detachment or Absence of Tesserae

NDT reveals surfaces of plastered mosaics, wherein areas of detached tesserae, as well as areas with moisture problems and presence of salts are displayed.

The boundaries of problematic areas are detectable,

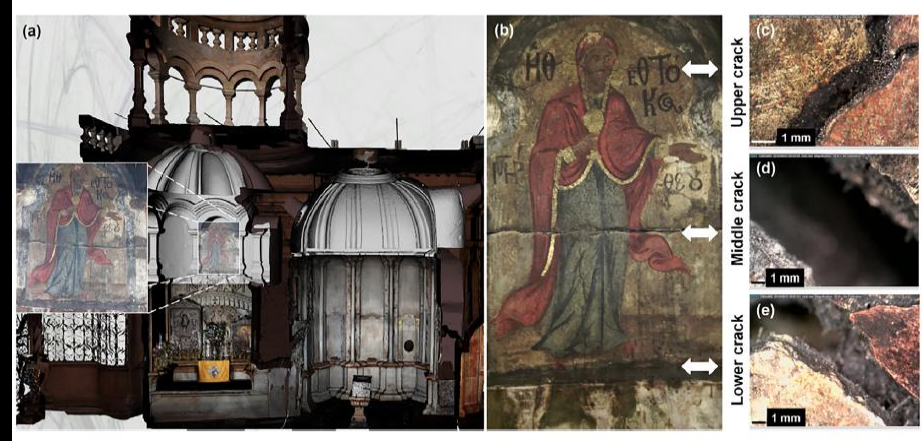
DM: Cracks investigation

Upper horizontal crack Middle horizontal crack Lower horizontal crack

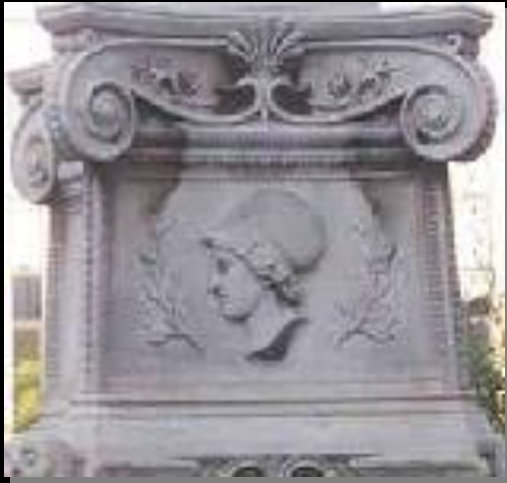
Aesthetical Evaluation of cleaning on pentelic marble architectural surfaces – Academy of Athens

Estimation of color parameters' modification of different decay patterns on exterior marble surfaces after cleaning

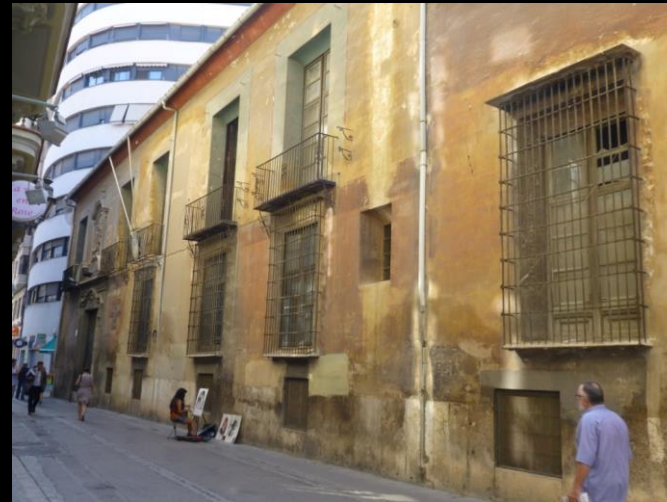
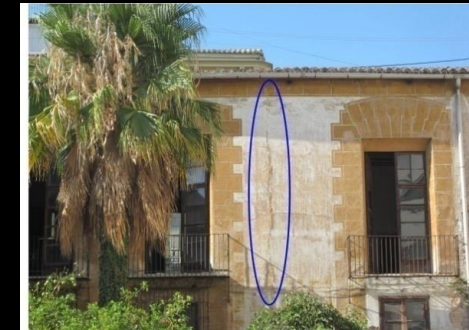
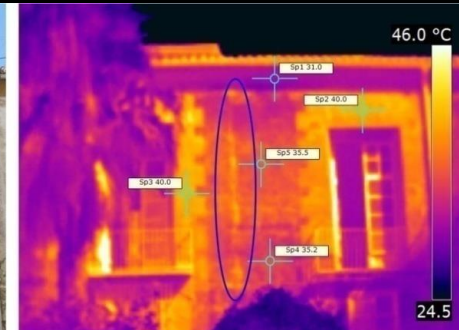
GPR, IRT application - Colegio del Arte Mayor de la Seda de Valencia

Assessment of preservation state of masonries Identification of hidden features

IRT & GPR: Identification of wooden structural elements within the masonry

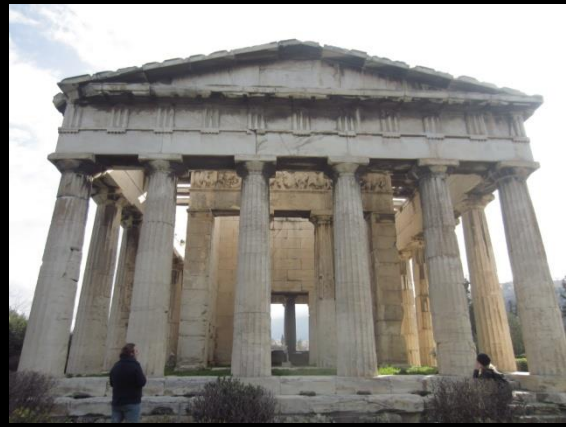
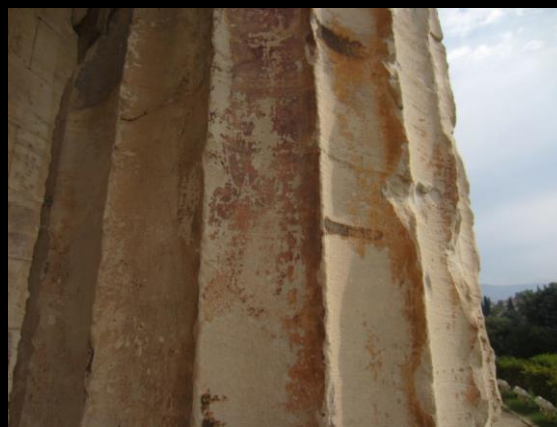
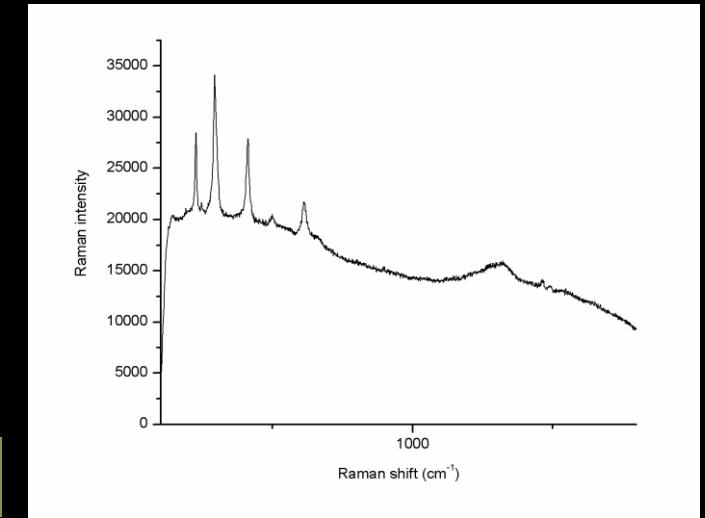
Hephaisteion (Ancient Agora, Athens): Patina identification

Characteristic bands of hematite: ($\alpha\text{-Fe}_2\text{O}_3$): use of red ochre.

Raman bands: 291vs, 410m, 506w, 608m, 1300 (br)

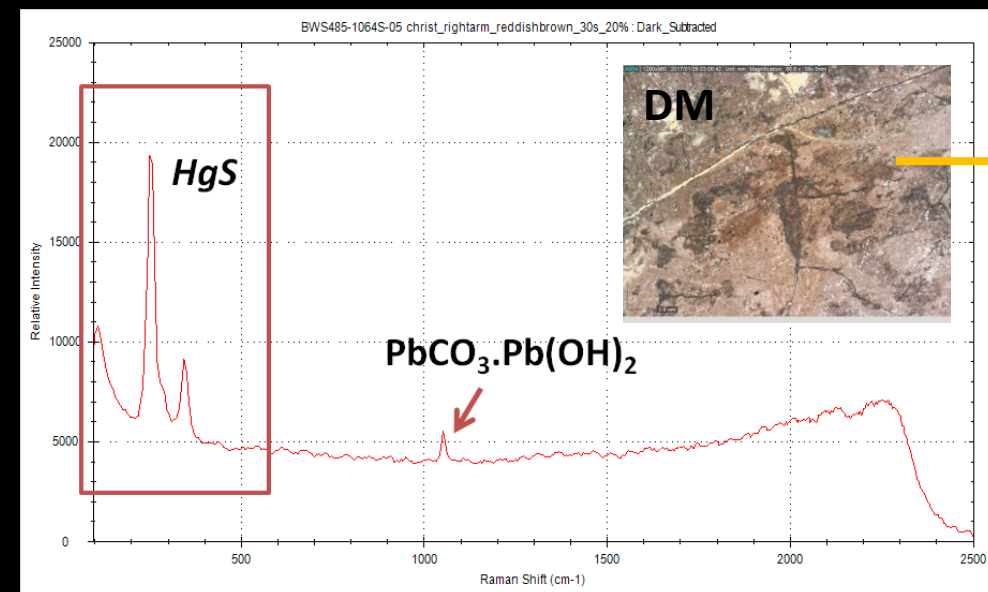
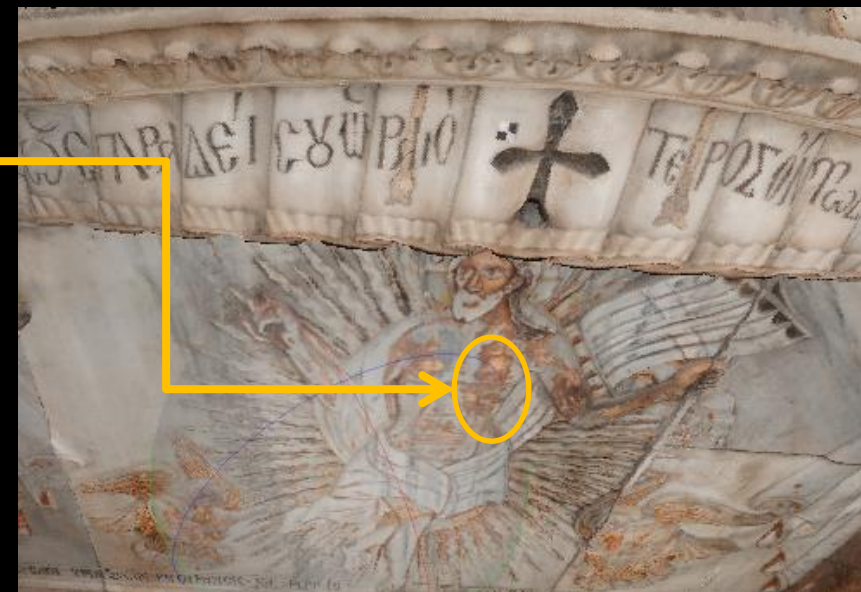
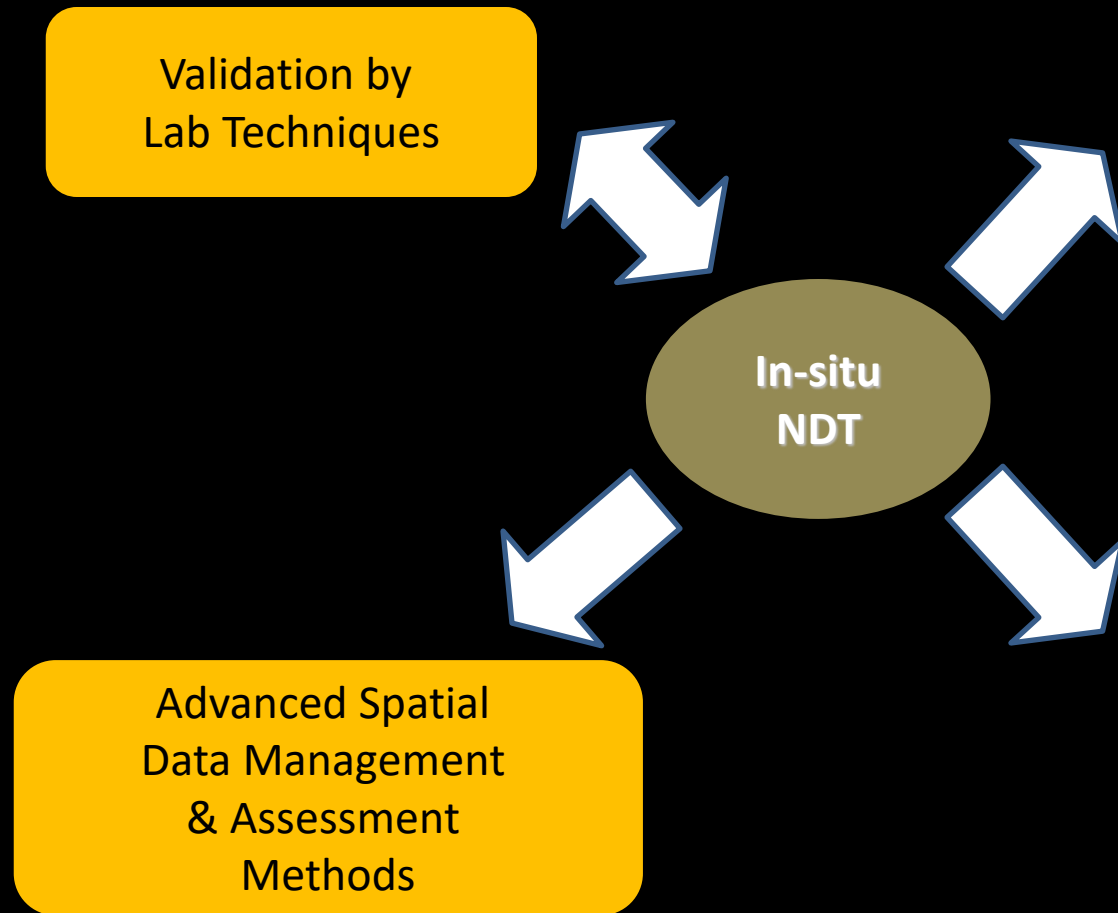
The gilded marble relief of Christ Resurrection in the Holy Tomb Chamber

➤ Flesh tones were achieved by a mixture of cinnabar (characteristic bands at 252 (vs) & 345 (m) cm^{-1}) with lead white (characteristic band at 1052 cm^{-1}).

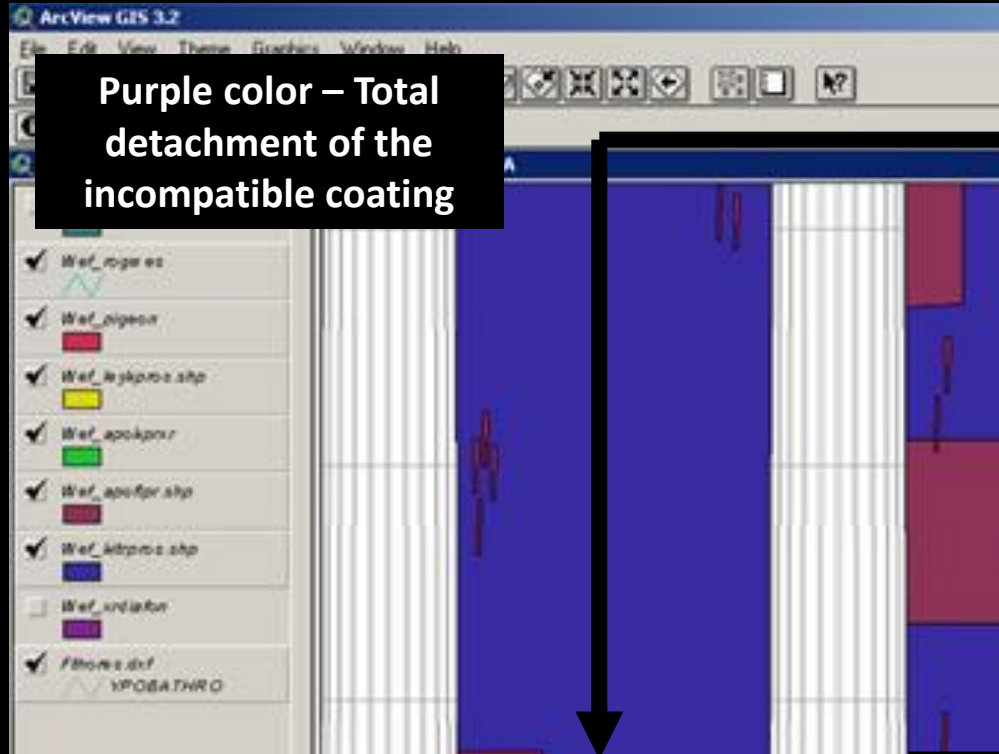
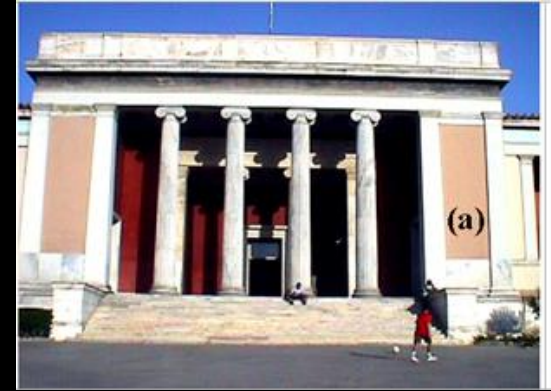
GIS thematic map of decay – plastered architectural surfaces of National Archaeological Museum of Athens

Spatial classification of decay patterns

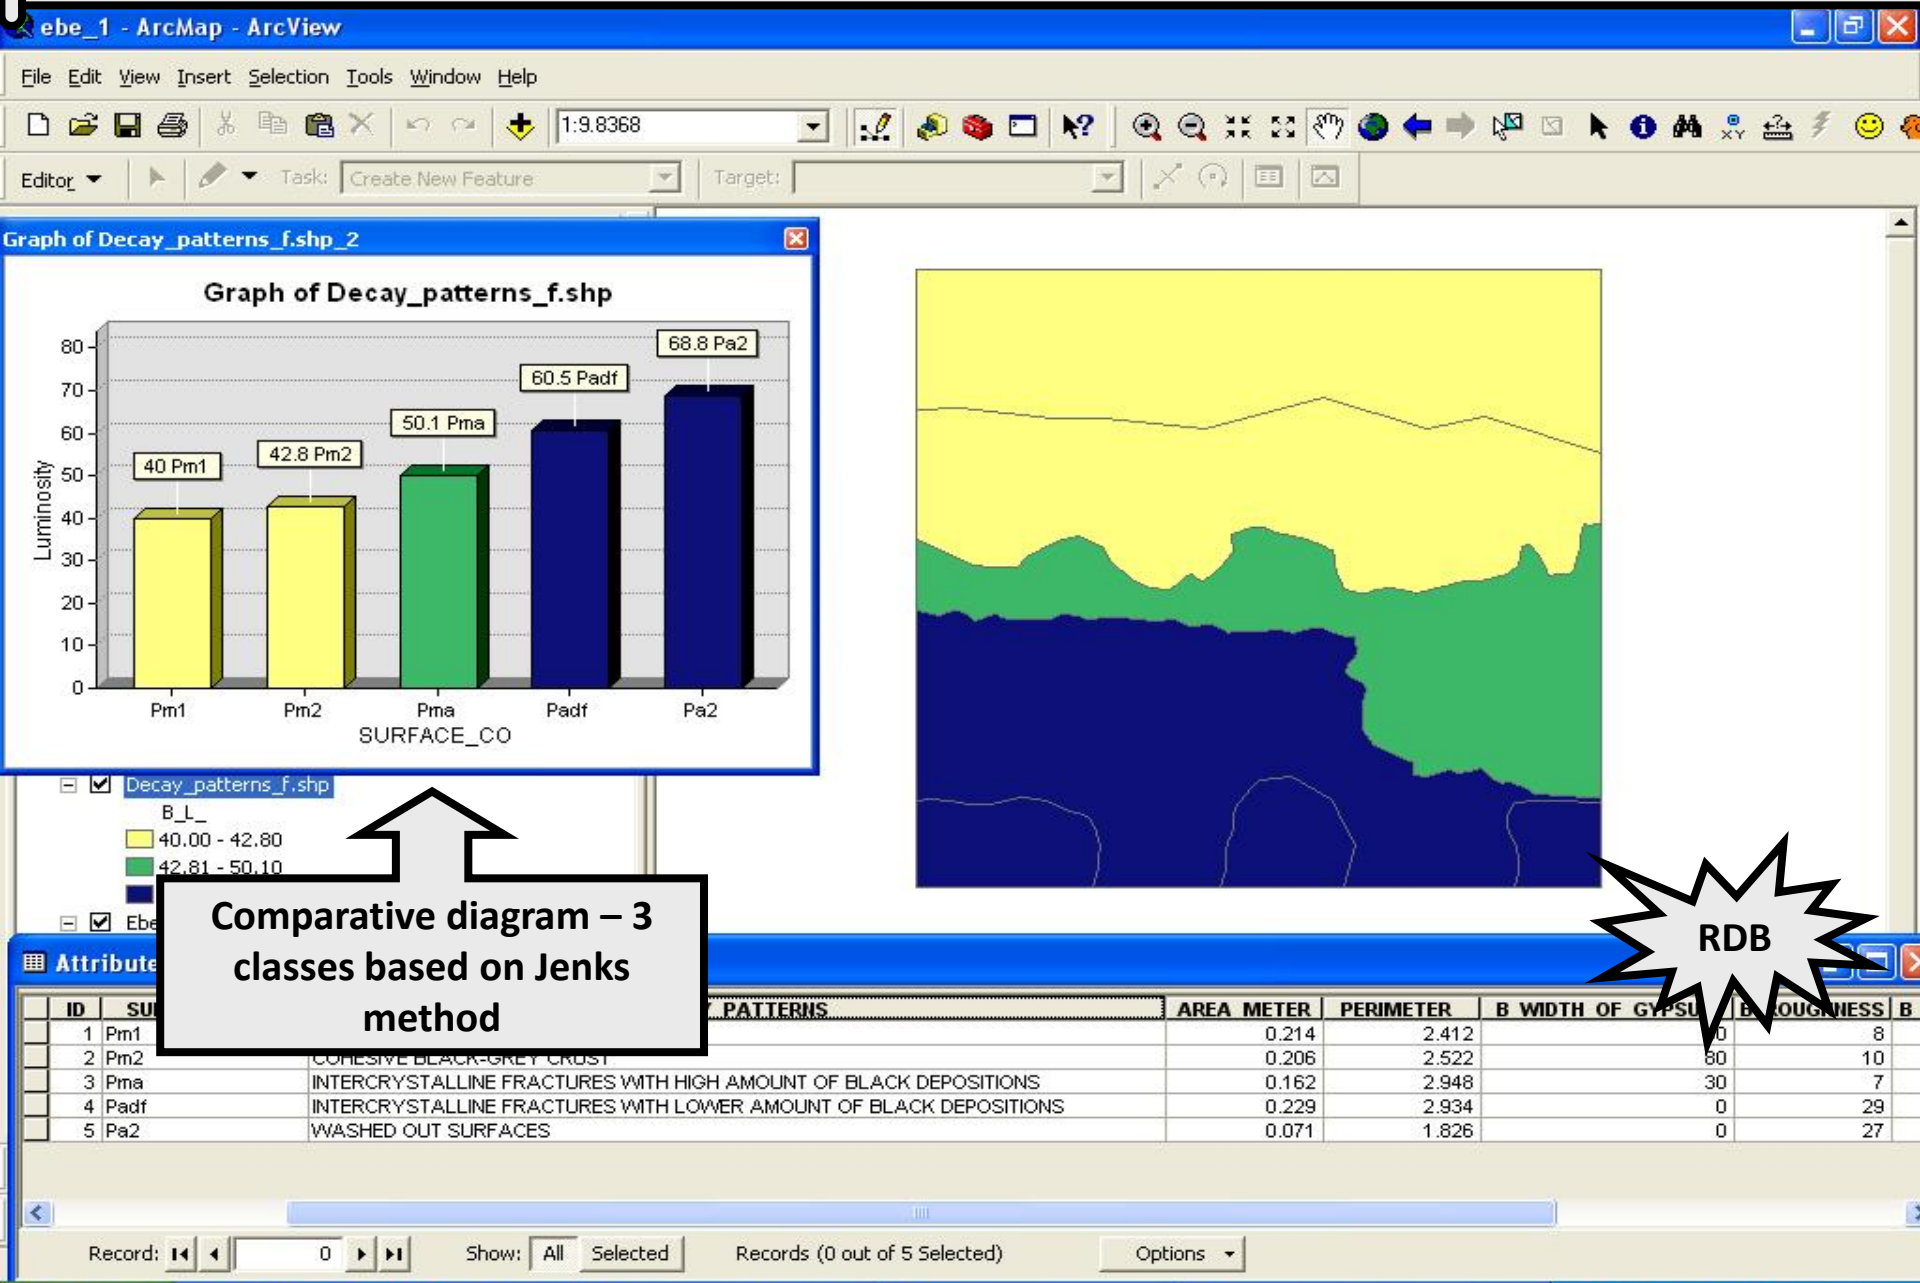
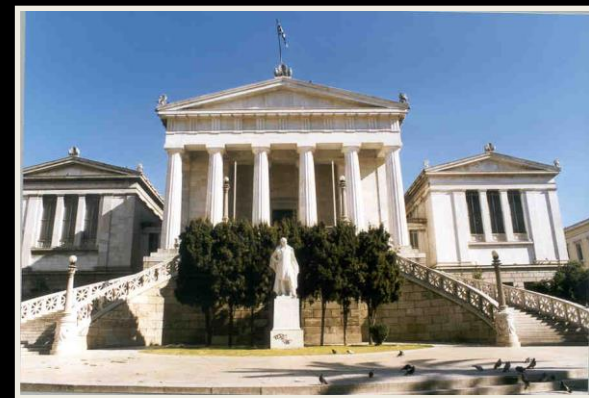
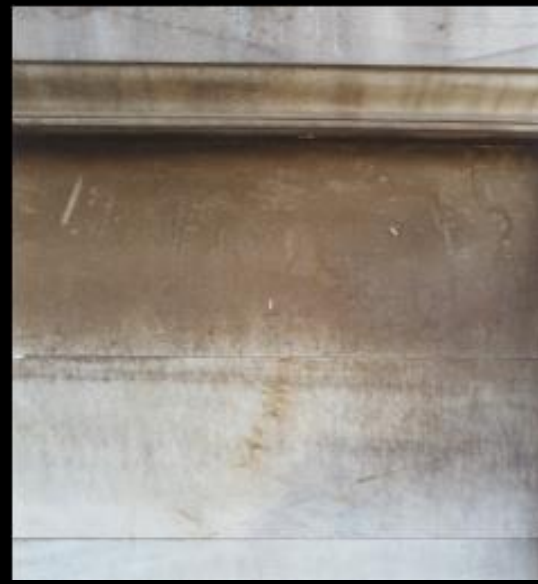
GIS thematic map of decay – attributing the physicochemical characteristic of color lightness L^* on the spatial entities of the architectural surfaces of National Library of Greece
