O3: Hands-on Framework The EDICULA Project | Multiplier Event 1 [E1]: The Historic City of Jerusalem, The Holy Sepulchre: A Hands-on Experience Learning from the Holy Sepulchre and Holy Aedicule

Jerusalem, 3 - 6 April 2022

Characterization and archaeometry of building materials of the Holy Aedicule – Compatibility
of conservation interventions

Dr. E. T. Delegou¹, Emer. Prof. A. Moropoulou²

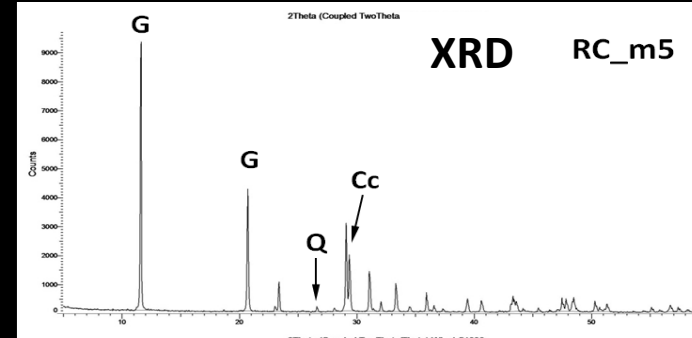
Mortars RC_m1 & RC_m5

RC_m5, mineralogical composition:
Gypsum, Calcite, Quartz

RC_m5, Calendar centered Age: late 16th c. CE, 1570 CE, reconstruction of 1555 by Boniface of Ragusa

RC_m1, mineralogical composition:
Gypsum, Calcite

RC_m1, Calendar centered Age: early 4th c. CE (335 CE), Constantinean era

- The interior marble facings (opposite the Holy Tomb) where a window was placed;
- (b) The window installed to provide visibility of the Holy Rock;
- (c, d, e) The location where sample RC_m1 was collected behind the marble facing, above the window;
- (f) The location where sample RC_m5 was collected, at the lower part of the Holy Rock crack.

How can we have two mortars located so close to each other, but as it concerns dating they are centuries apart? (335 AD – 1555 CE)

- The fact that the RC_m1 mortar sample was in contact with both the Holy Rock and the marble facing, is an indication that the specific panel could have been in place since the Constantinean Aedicule.
- In the case that the marble panel is a later addition, then we can assume that the Holy Rock was at least plastered in the interior and not bare during the Constantinean era.
- Regarding RC_m5, the mortar sample taken within the Holy Rock crack, indicate that some panels were placed or replaced or even reattached during the Boniface restoration, without excluding previous or even subsequent restoration phases of the Holy Rock crack area.

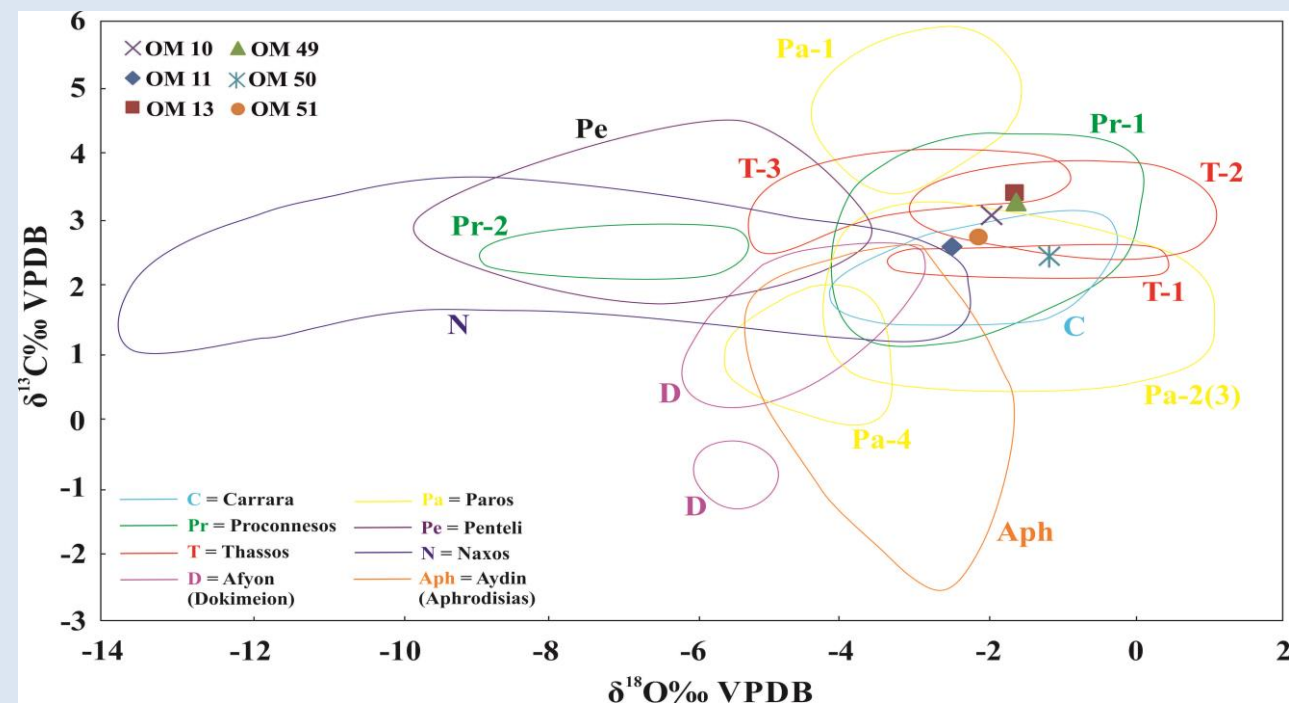
Isotopic Discrimination plot among Holy Aedicule samples and field of ancient marble quarries

The techniques employed proved to be adequate for the identification of their provenance and the aforementioned data suggest that the Holy Aedicule white marbles examined herein, originate from the island of Proconnesos and in particular they belong to the variety type Proconnesos-1.

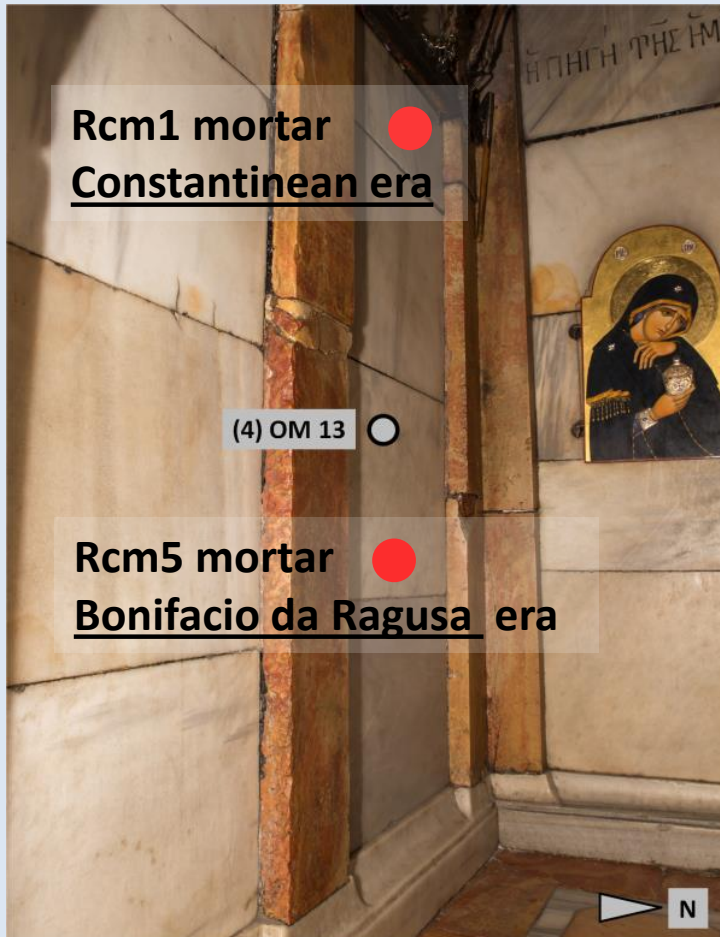
sample OM13

The marble sample taken from the marble facings of the interior of the Tomb Chamber, opposite the Tomb of Christ (sample OM13), where the observation window is in place today, was most probably placed into its current position at the time of the Bonifacio da Ragusa restoration, since Rcm5 mortar is dated to his era.

However, we cannot exclude the possibility that this member was present from the Constantinian era, since marble members re-use was a common practice throughout the centuries, and Bonifacio da Ragusa reinstalled it.

This second scenario is rather possible if we consider that the mortar Rcm1 (selected from behind a marble slab above the one examined in this study (OM13), was dated to 335AD (calendar centered age) that is the Constantinian Aedicule.

Thus, it is highly likely that the interior of the Tomb Chamber was adorned with Proconnesian marbles from the time of Constantine.

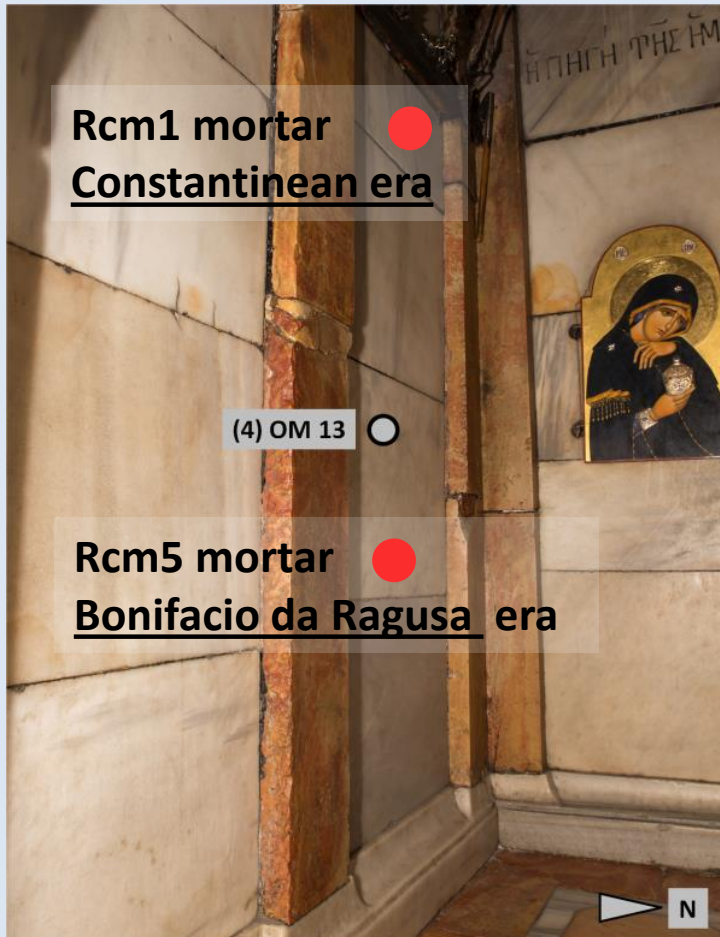
sample OM13

OM13 could have originated ONLY from the ancient quarry C5b.

So, if this marble member was first installed in the Constantinian era and Bonifacio da Ragusa reinstalled it, and taking into account that the lower tomb plate (OM10) was also installed in the Constantinian era, perhaps both members were quarried from C5b, which is the only common quarry of origin for both samples.

Furthermore, quarry C5b is also a common origin quarry with sample OM49, which is the marble fragment, perhaps the decorative edge of the lower marble plate, as already mentioned.

Thus, if OM13 & OM49 are of the Constantinian era such as the lower Tomb plate (OM10), then, all three of them could be originated from the ancient quarry C5b.

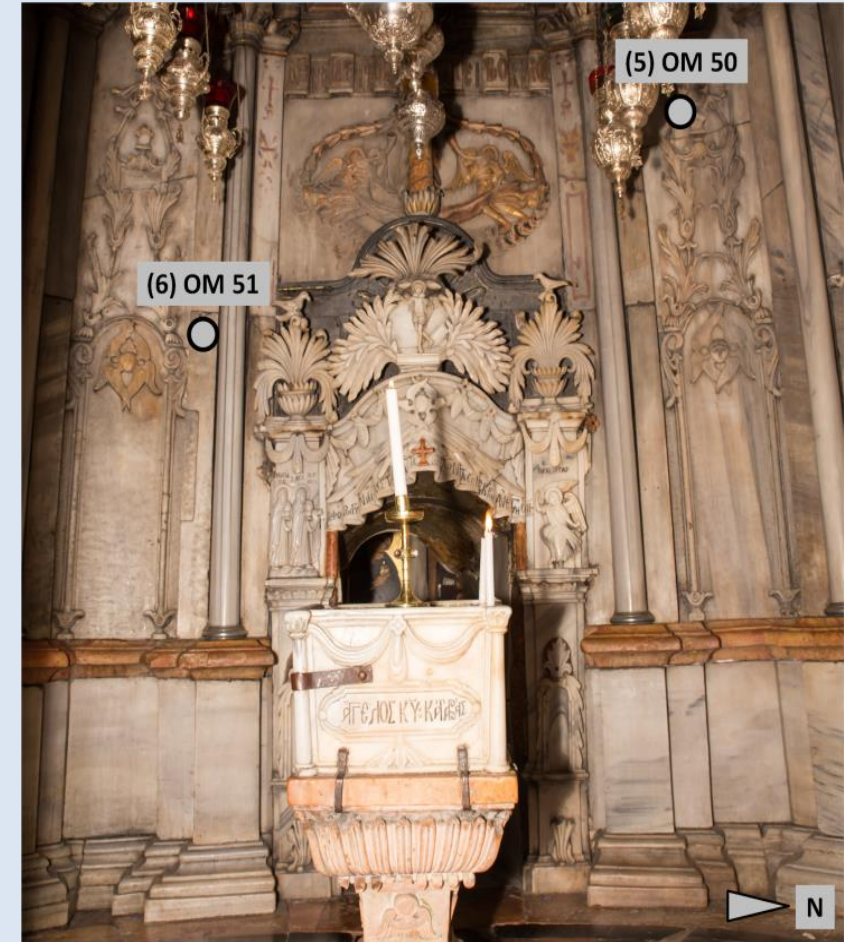
The two marble samples (OM50, OM51) from the west interior wall of the Chamber of the Angel, were collected from marble members, which were placed probably during the Crusaders construction phase, without, however, excluding the Bonifacio renovation or even the major reconstruction of Kalfa Komnenos in 1810.

Altintaş and Mandira are the only common origin quarries for these two samples and it is definite that they could not have originated from the same quarry as OM13 and OM49 (C5b).

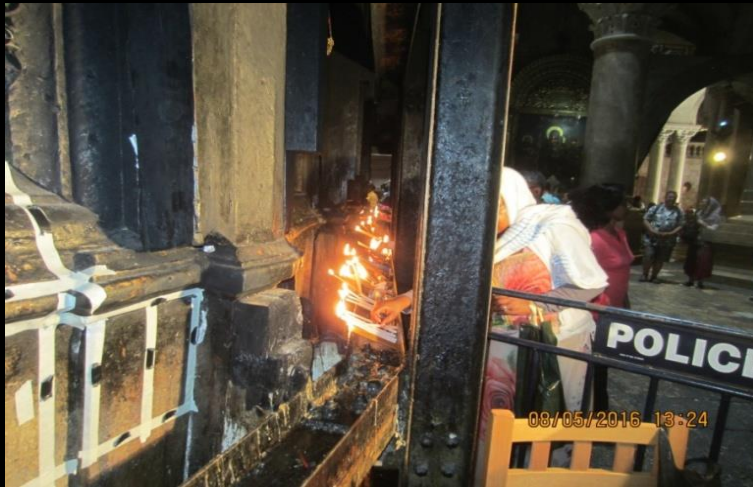
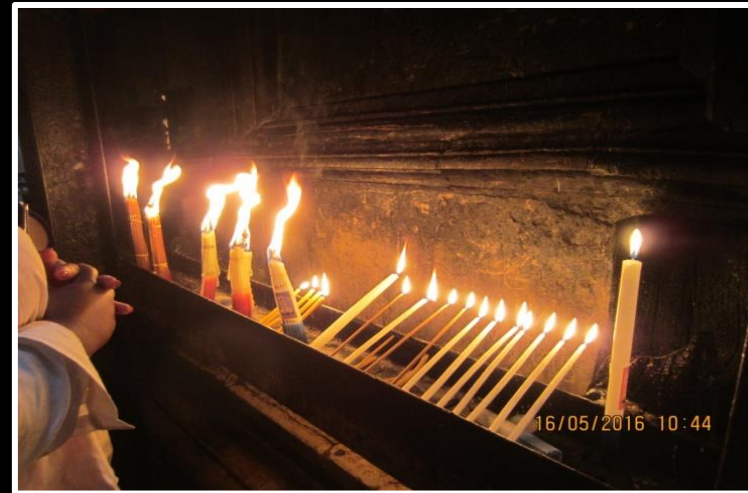
The problem:

Positioning of the burning candles on the metal frame → Candles' burning close to or even in contact with the architectural surfaces of the Holy Aedicule → Candles extinguishing on the facades

The result:

High temperature variations on the stone facings → Significant thermal stresses developed on the stone facings → Aesthetical and physicochemical degradation → Accumulation of black and oily depositions

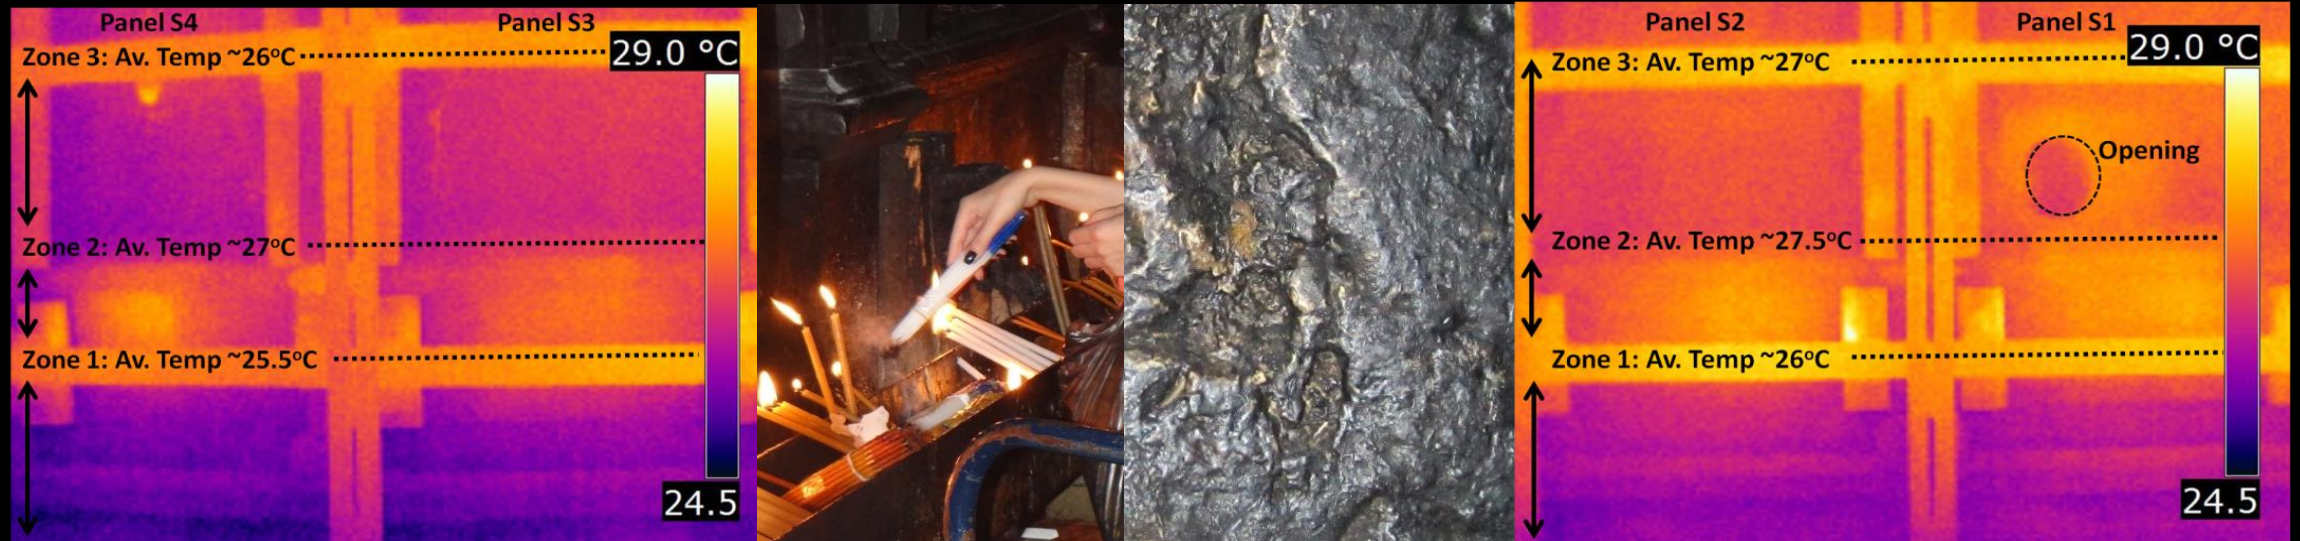
JUST AFTER REMOVING THE BURNING CANDLES

- Temperature heterogeneity at the investigated part of the façade
- Anisotropy of heat distribution over stone facings and subsequently in the deeper masonry layers via the mechanism of heat induction
- The thermo-hygric behavior of each building material (stone facings, filling and joint mortars and masonry building stones) is differently affected per height zone, as well as in depth, resulting in a corresponding thermo-hygric anisotropy

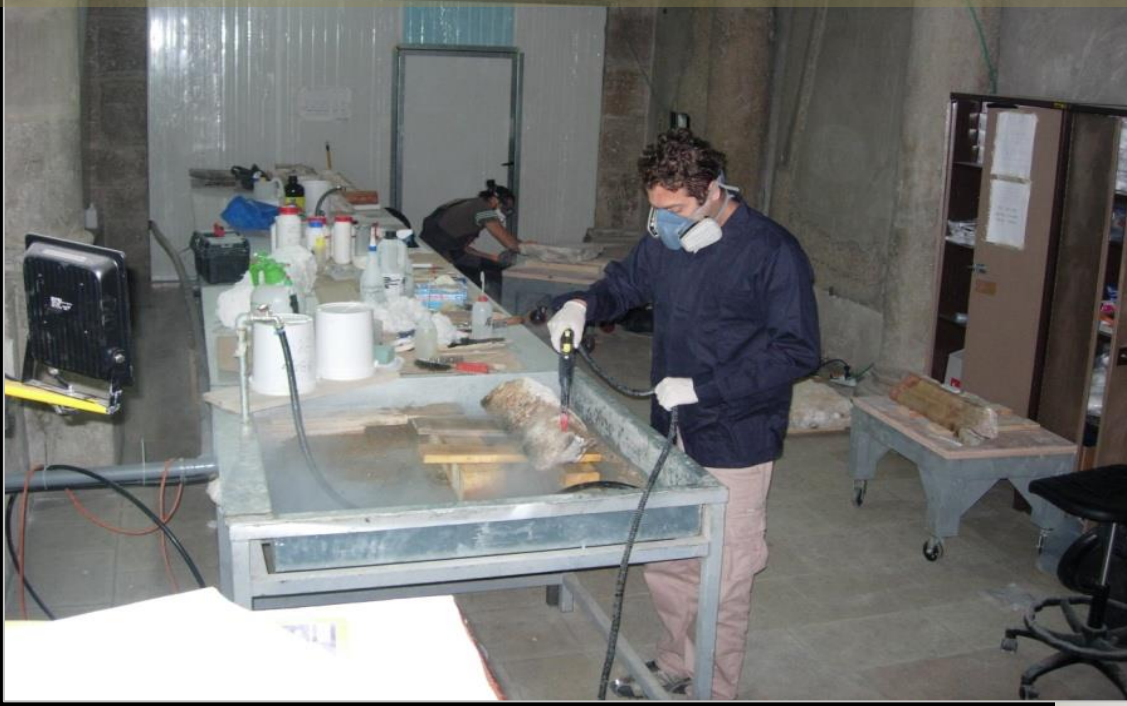
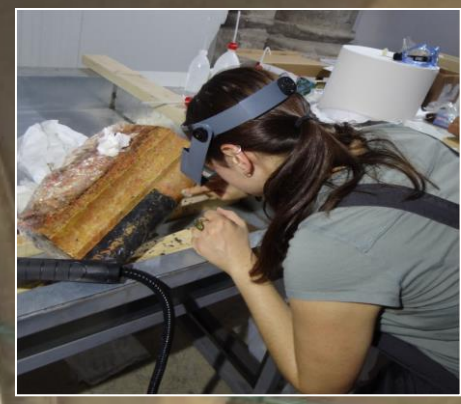
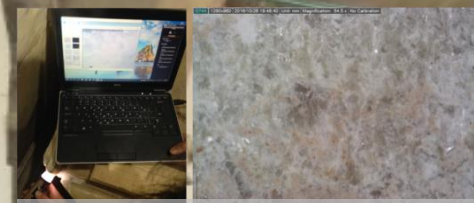
The Conservation lab at the Franciscan gallery: the heart of the conservation interventions

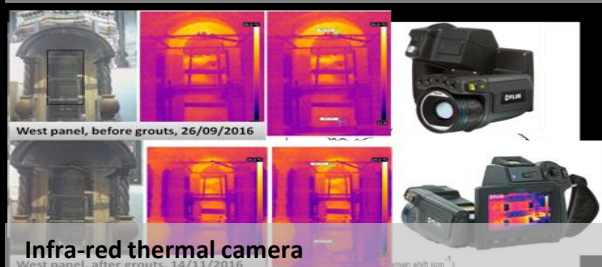
Portable Spectrophotometer

West panel, before grouts, 26/09/2016

Infra-red thermal camera

West panel, after grouts, 14/11/2016

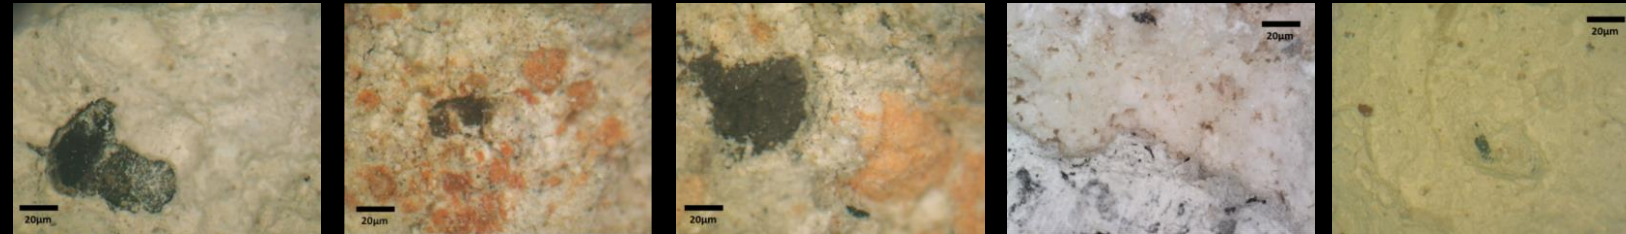
Digital Microscopy: Classification of historical mortars

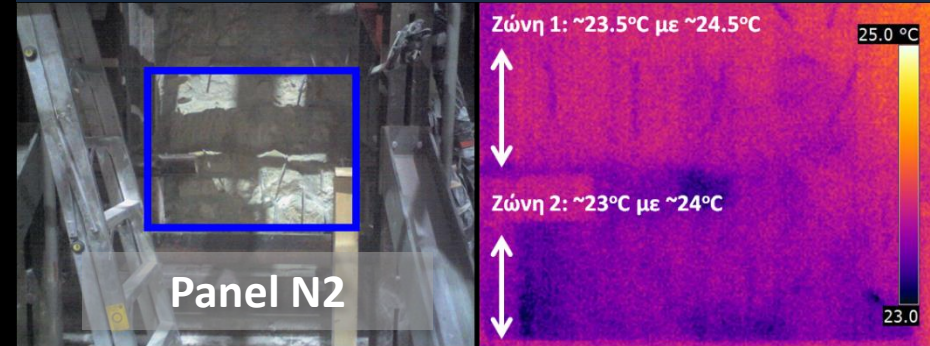
The lower masonry parts present lower temperatures.

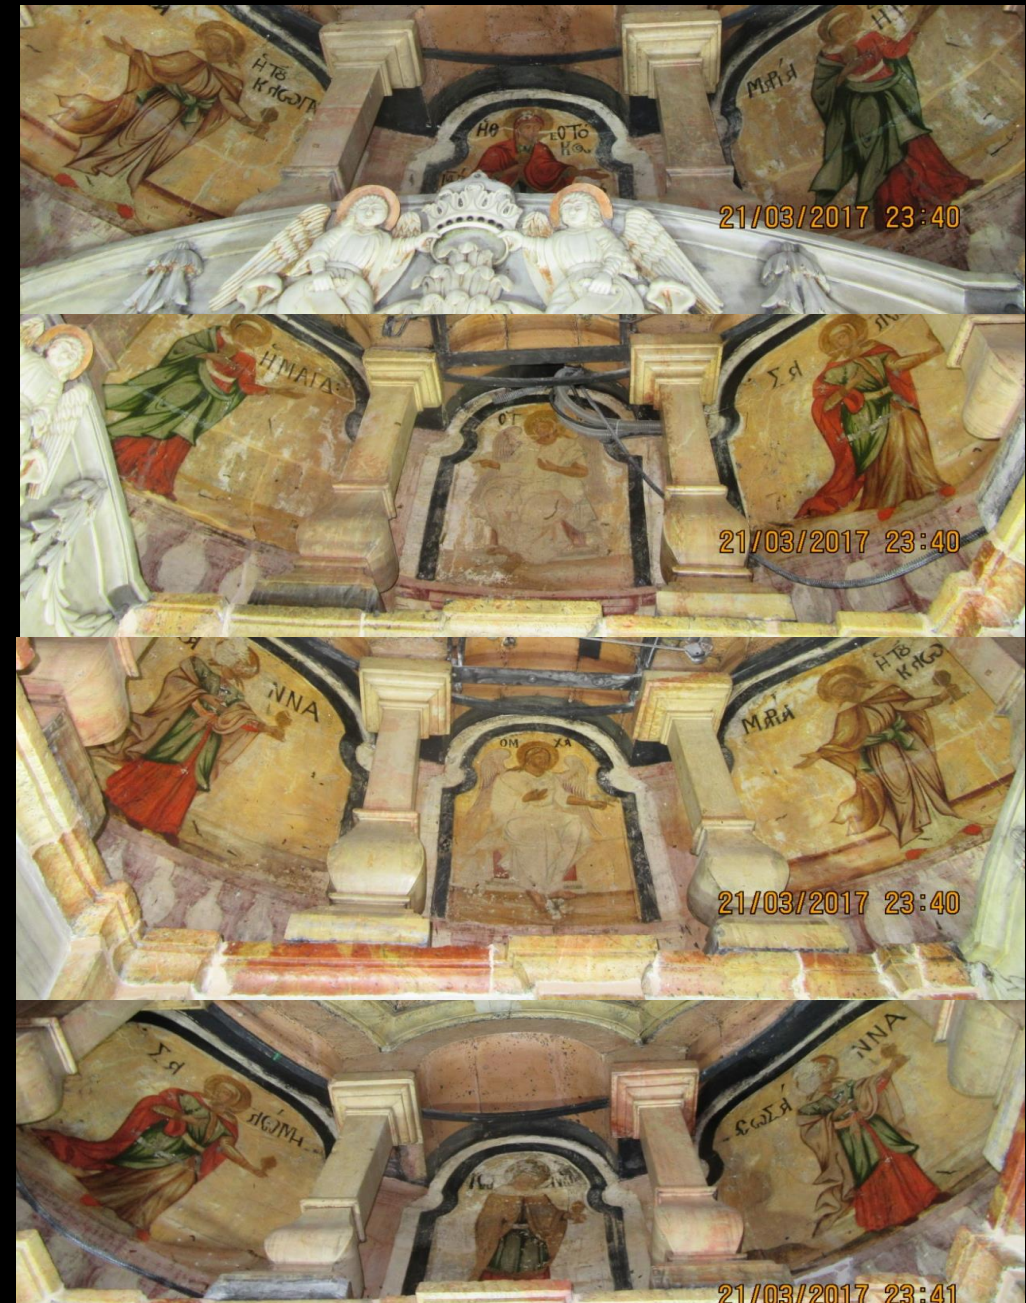
The wall painting of the Myrrh-bearers

➤ The upper part of the Holy Tomb is crowned by a dome that its base is decorated by a wall painting depicting the Myrrh-bearers, Angels Michael and Gabriel, and Virgin Mary.

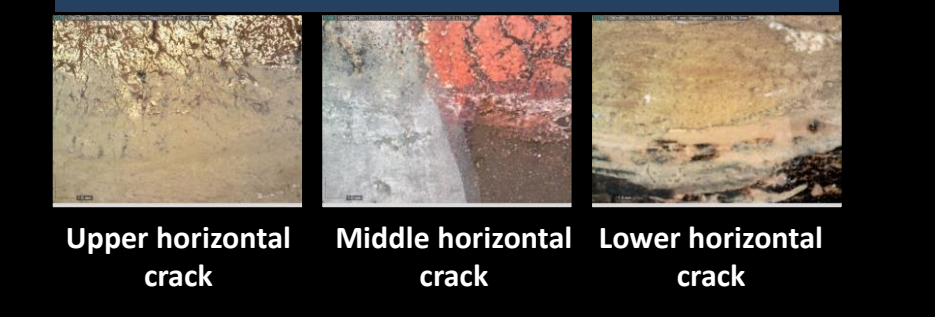
Digital microscopy – aesthetical conservation
