THE EDICULA IMMERSIVE EVENT

The case of the Varnakova Monastery in Fokis: The rehabilitation of the Katholikon

The Architectural Approach

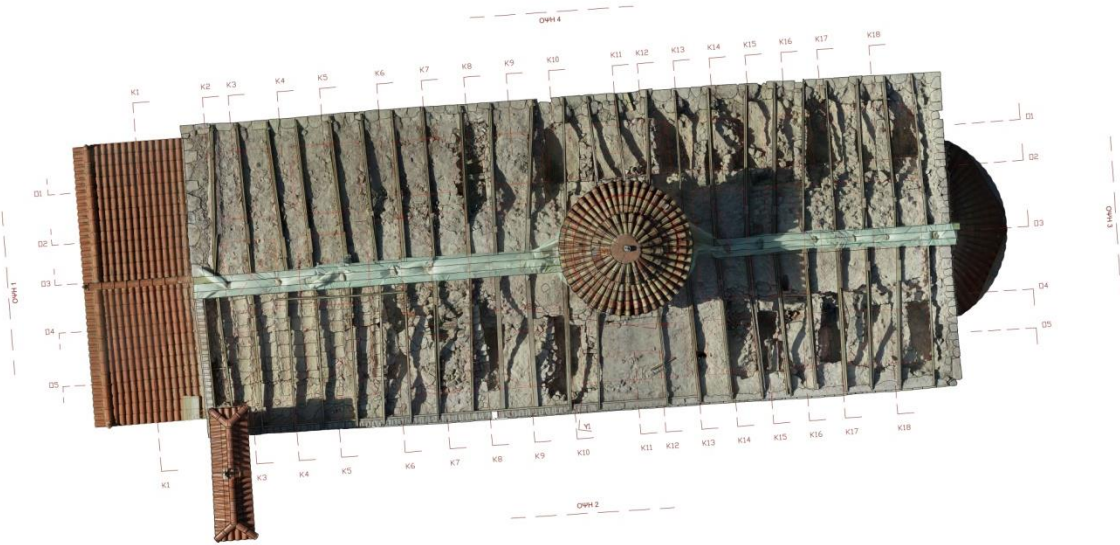
Documenting the roof during the project
28-2-2022

During the repair works, the **roof** was opened and its **construction was revealed**. It is a complex system of the newer phase, in which the slope of the roof is formed by stone gables, the gaps between which are bridged with wooden logs. The gaps are filled with stones and mortar. Stone slabs, wooden logs, slats and tiles were placed on top.

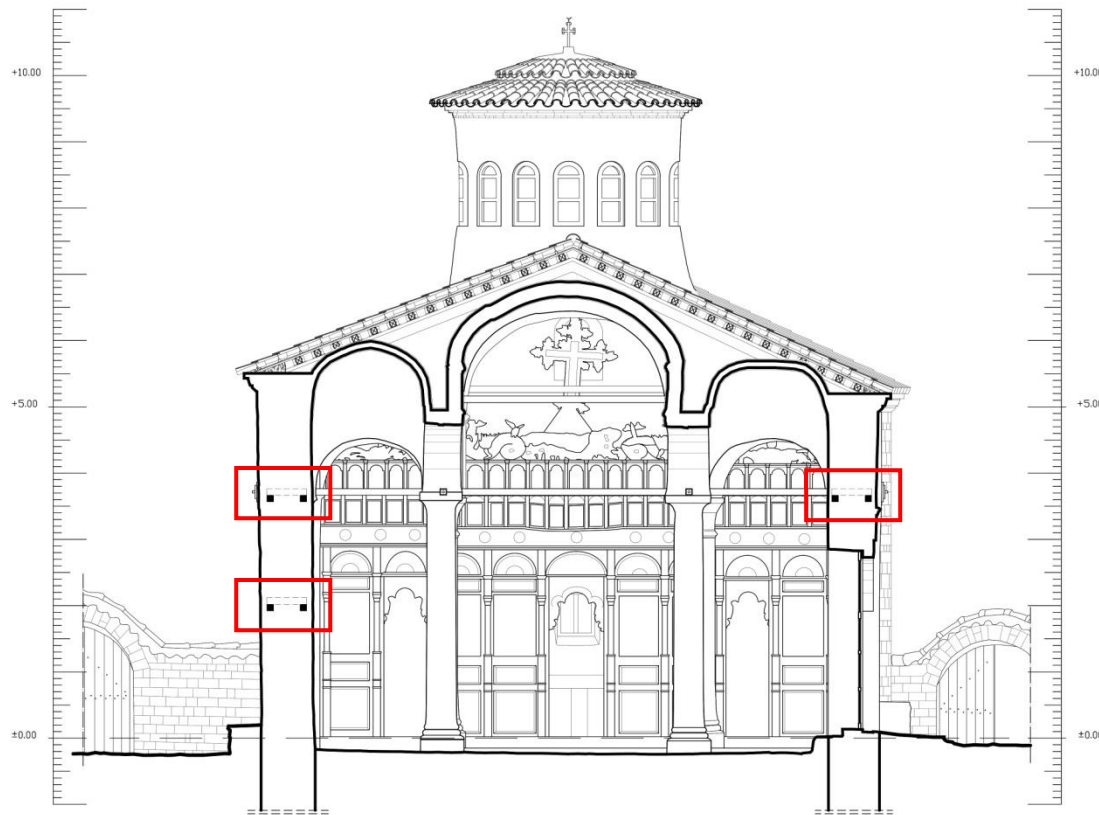
The arches in the transverse direction of the temple show significant pathology, in contrast to the arches in the longitudinal direction, which are in good condition. The arches are connected with wooden tension rods in both directions.

The out-of-level movement of the North and South wall has caused the cracking of the entire vault in all three naves.

Reinforcement of masonry

3. Installation of tension-compression rod system in the arches

- To strengthen the vaulting, a general application of grouting is carried out and then tension-compression system is placed at the origin of the arches in both directions inside the temple.
- Alongside, vaulting reinforcement with stainless steel mesh is placed.
